BENEFITS OF QUARTERLY AND POST-STORM MONITORING TO OVERALL PUBLIC RELATIONS AND URBAN STREAM RESTORATION PROJECT SUCCESS

August 2023

Upper Watts Branch Stream Restoration

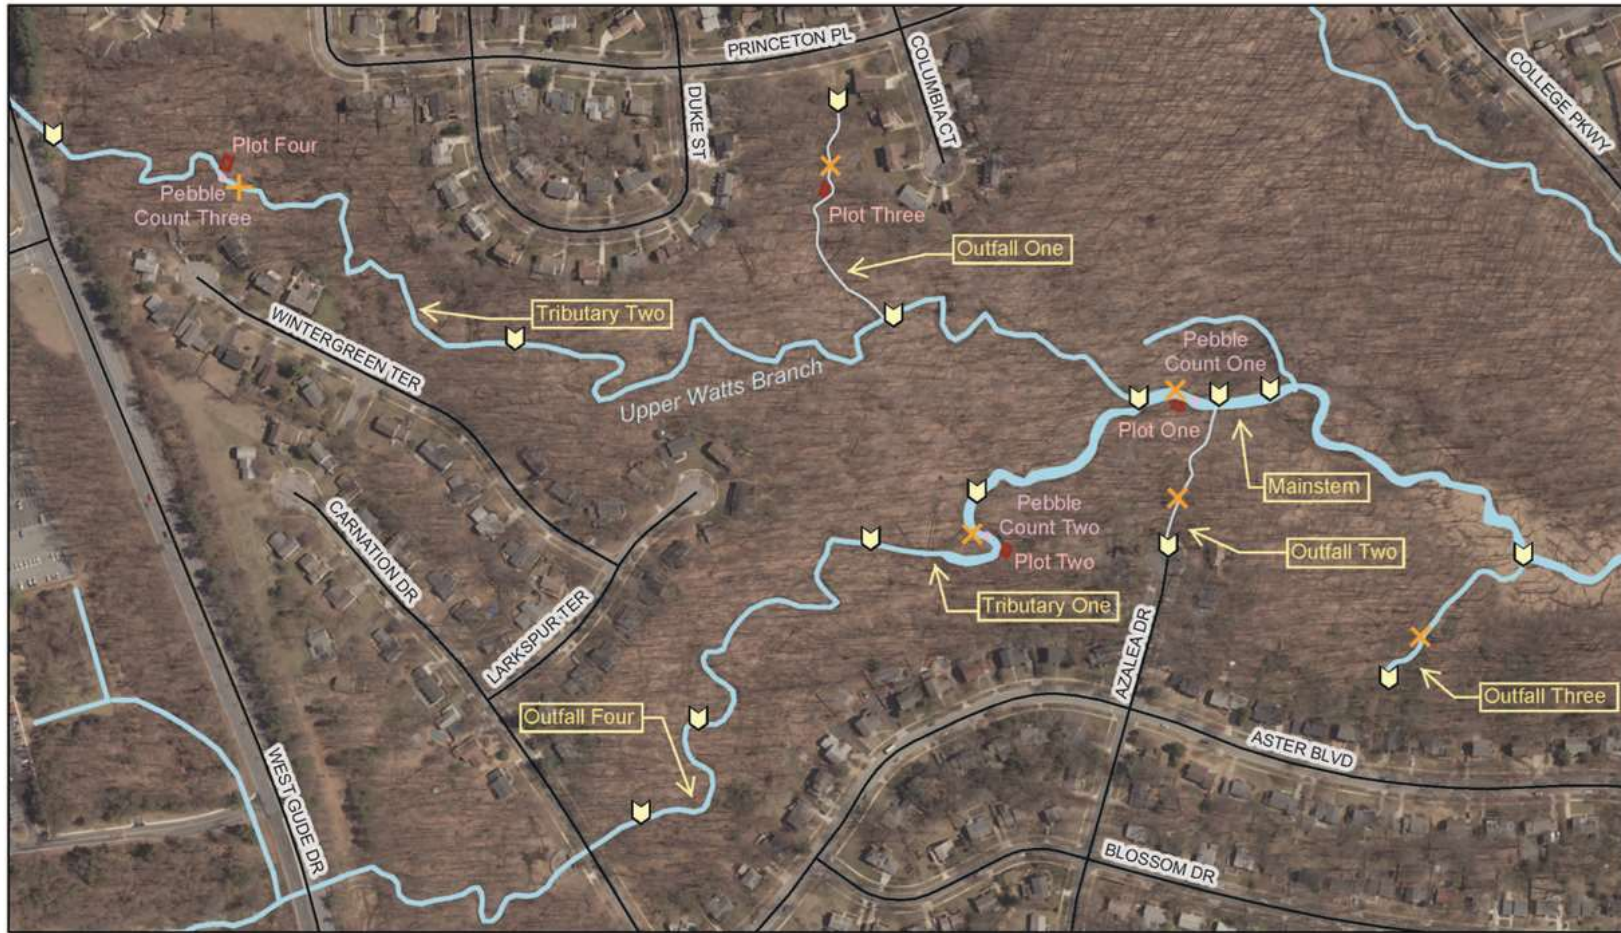
Approx. Limits of Construction
-

Vegetation Plot Locations
-

Upper Watts Branch Stream
-

Pebble Count Locations
-

Cross Section Locations

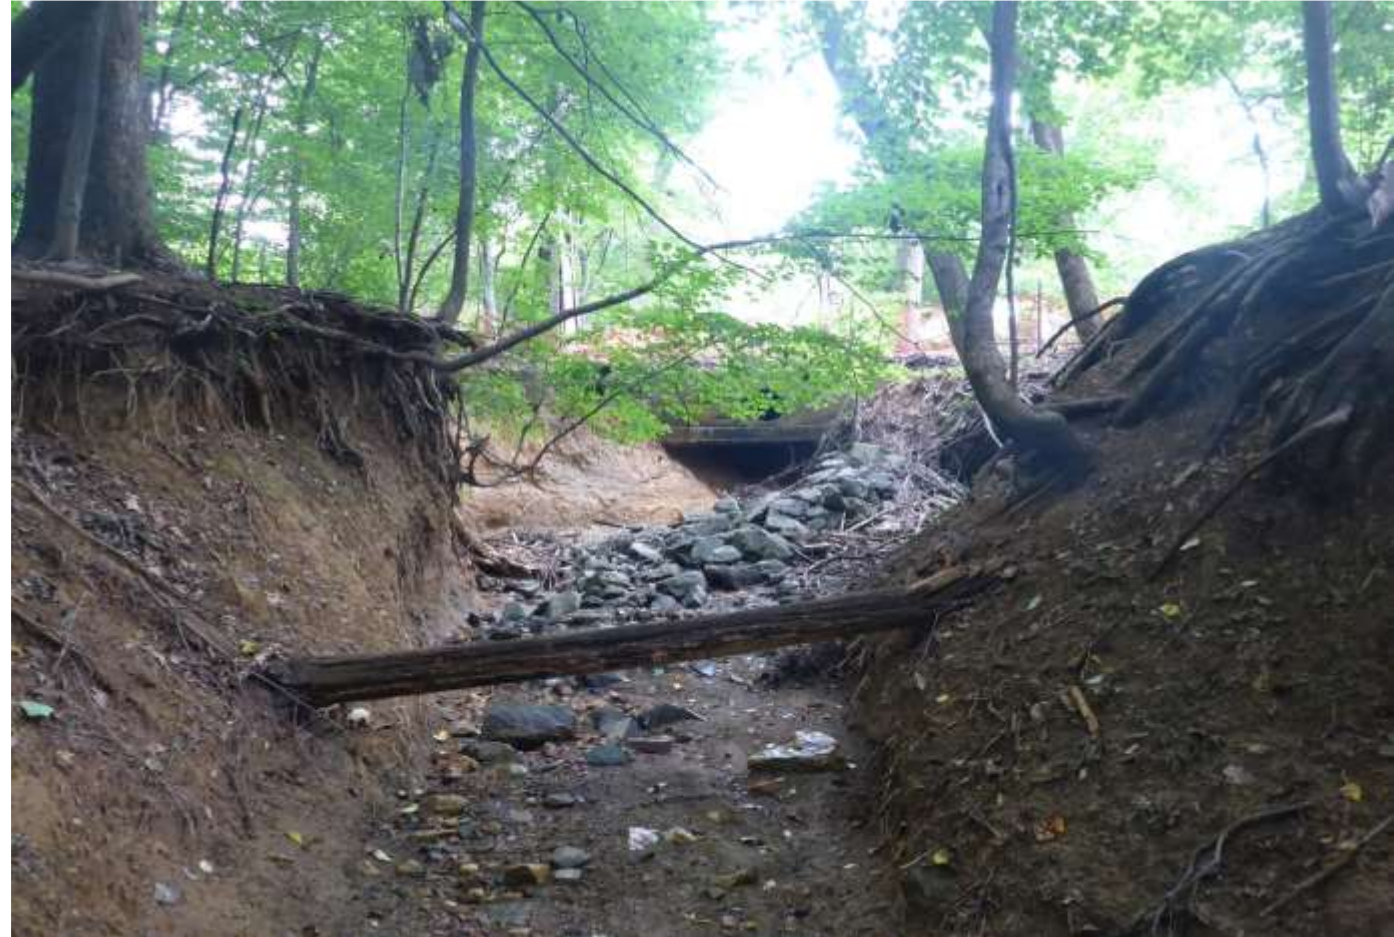
Upper Watts Branch Stream Pre-Construction

- U.S. Army Corps of Engineers reviewed this project and granted authorization under the Maryland State Programmatic General Permit (MDSPGP-4), as a Category B, Review Required
- Residential Outfall One of Four
 - Eroded Stormwater Outfall
 - Approx. 15ft Deep within Gully
 - Step Pool Storm Conveyance
 - Runoff from Local Development

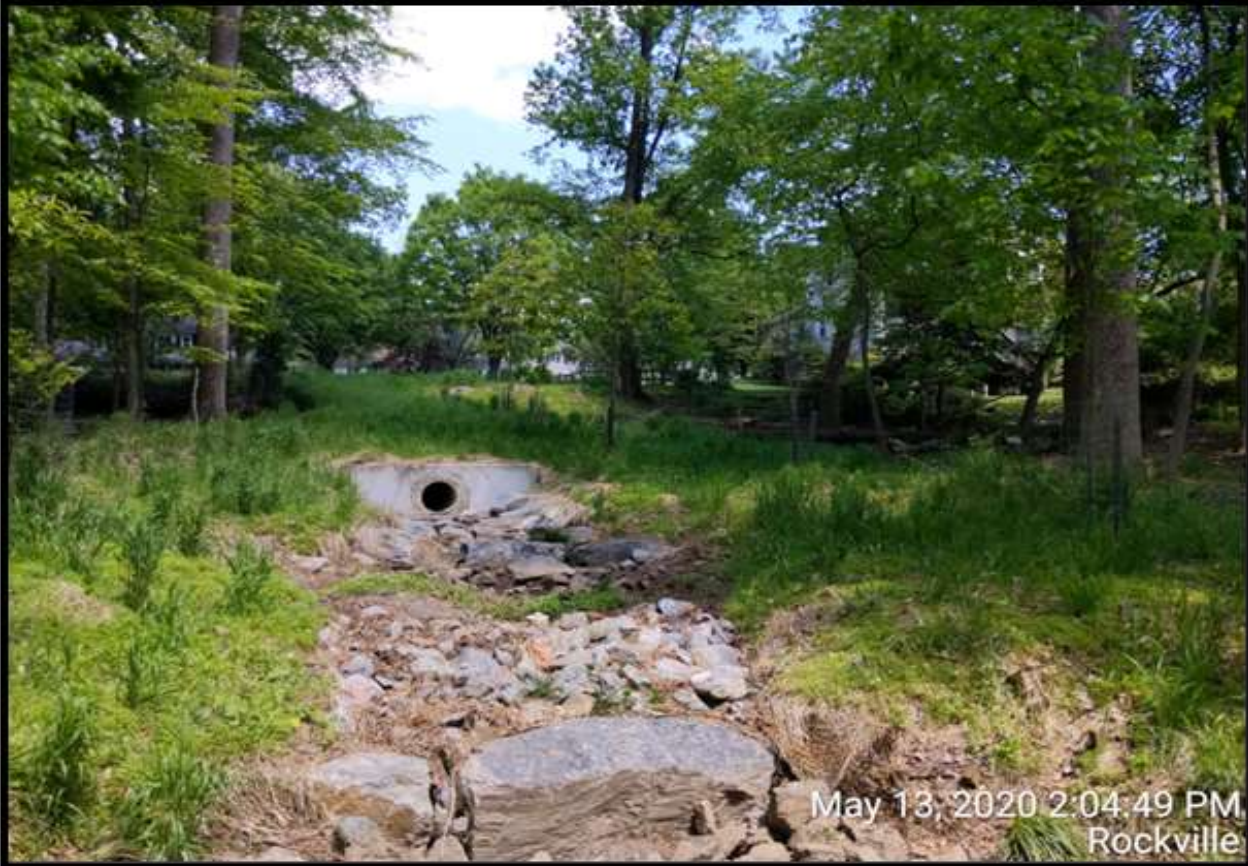
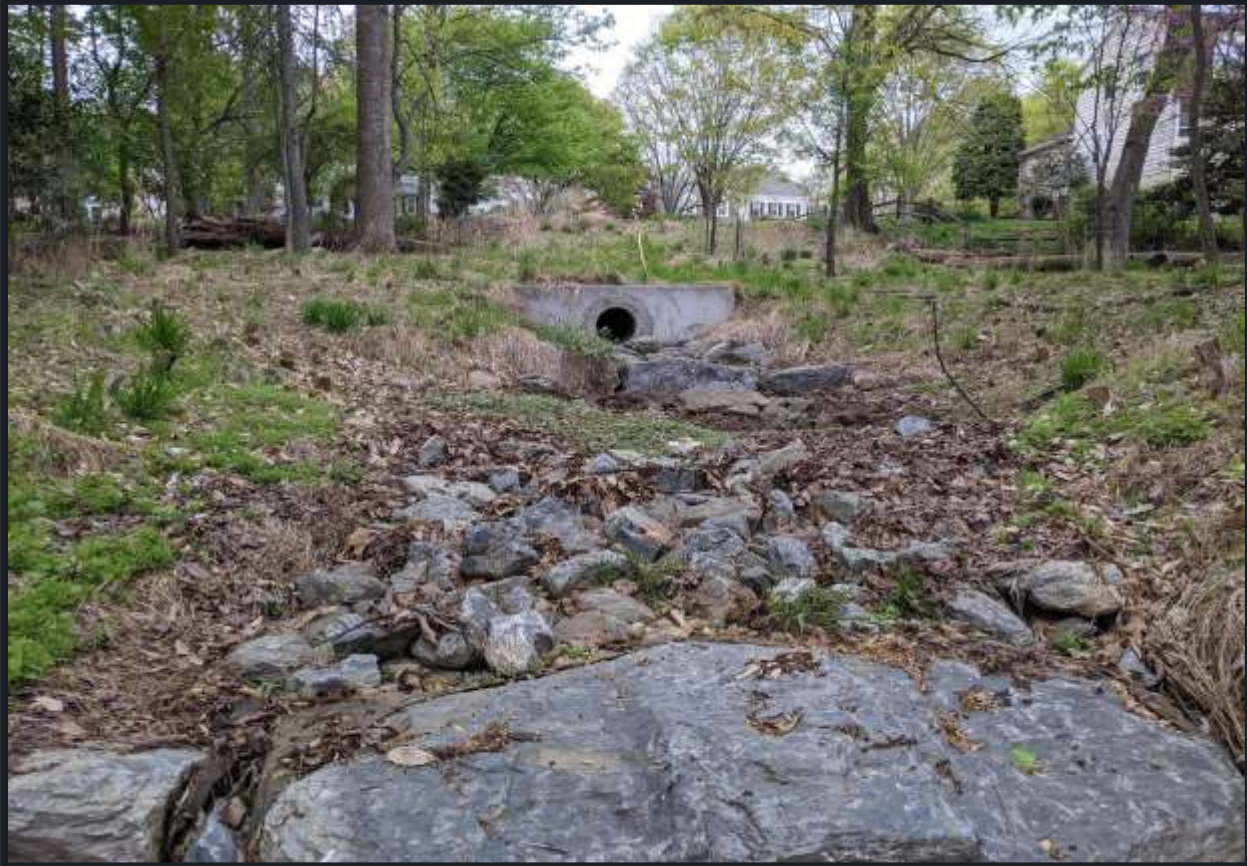
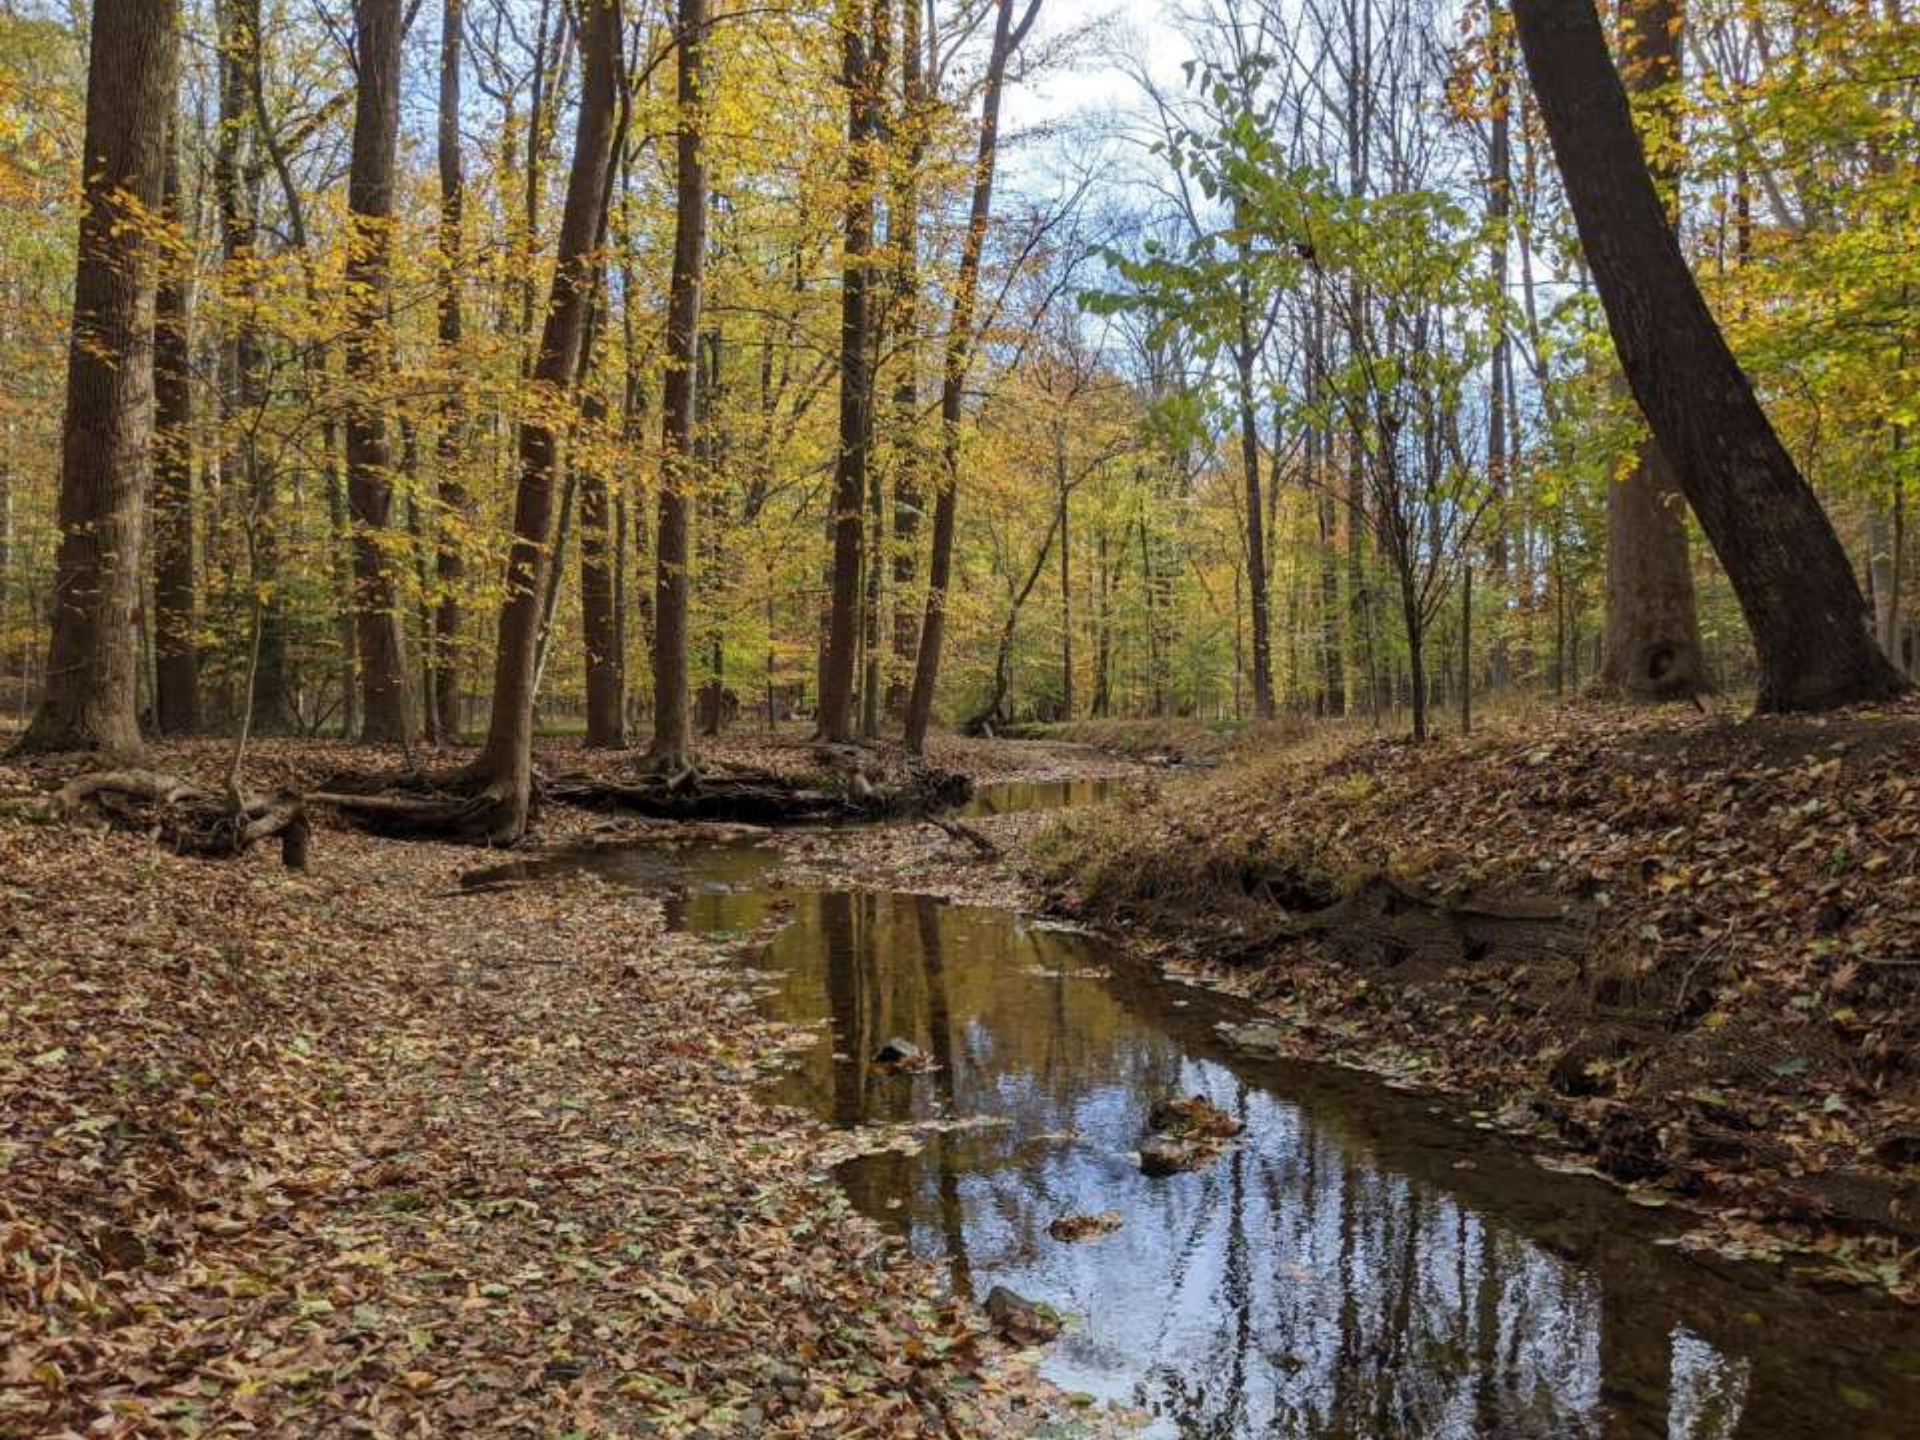
Upper Watts Branch Stream Post-Construction

- Stream Profile
- Cross Sections
- Pebble Counts
- Native Species Health
- Post-Storm Monitoring
- Visual Observations of Overall Stability

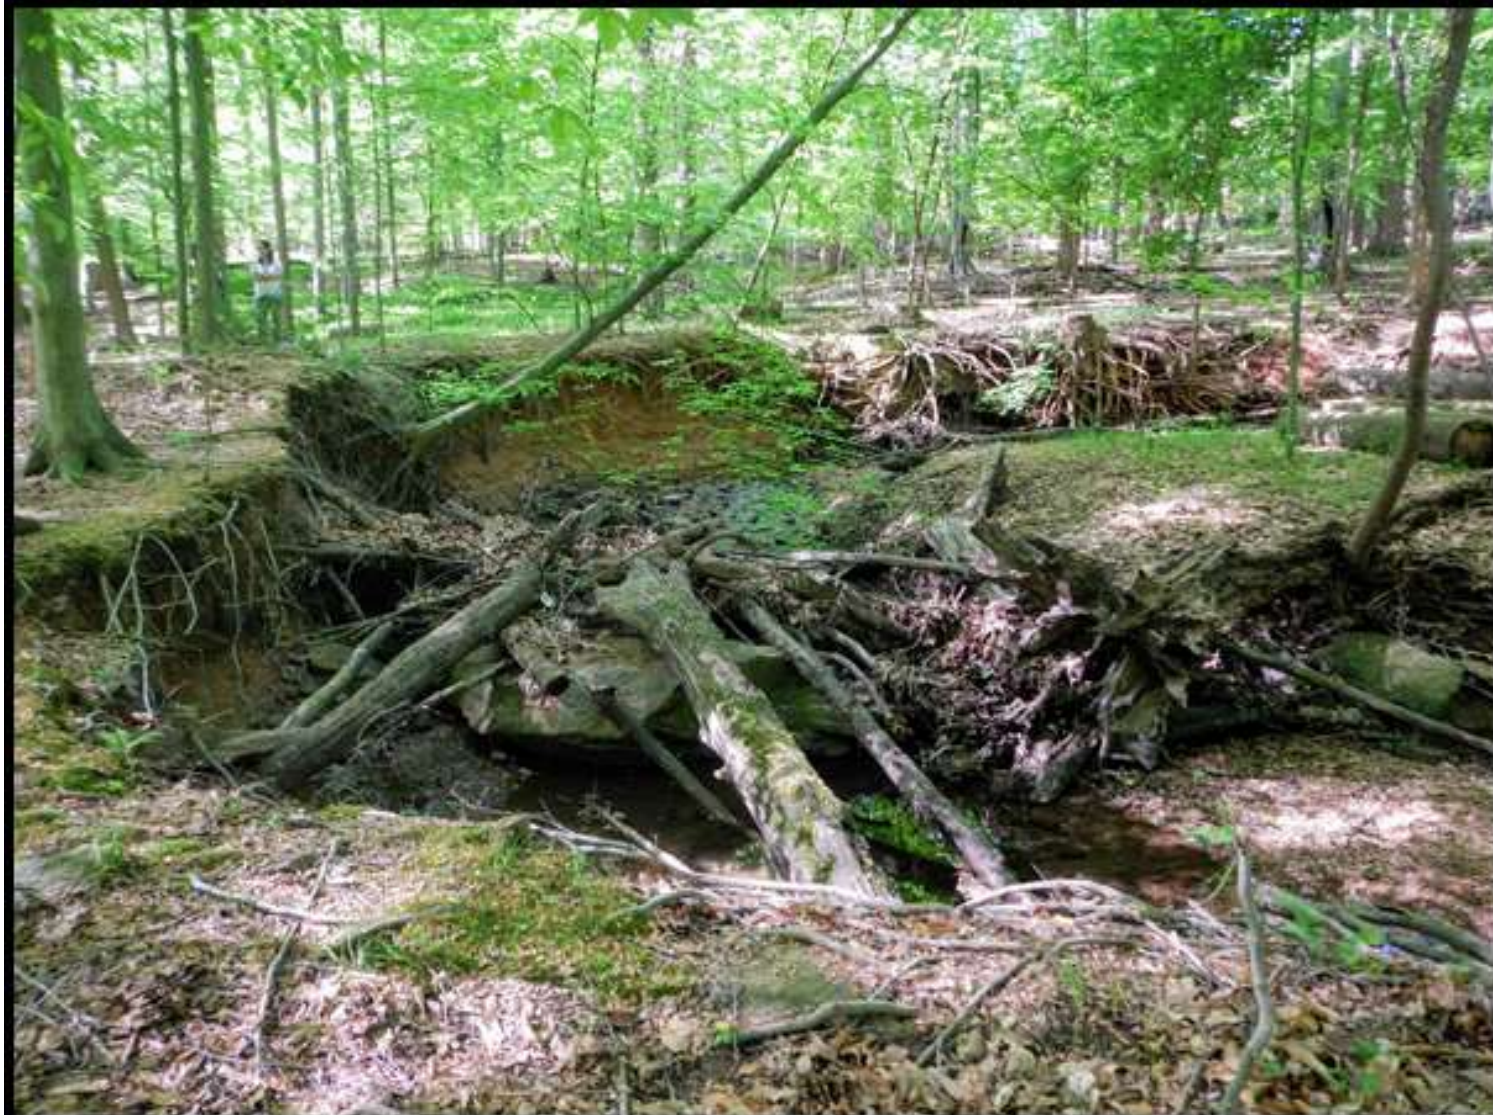
Upper Watts Branch Stream Pre-Construction

- Tributary One
 - Eroded Stream Bank
 - Undermined and Exposed Sewer Manhole
 - Risk of Failure / Contamination
 - Adjacent Residential Area
 - Runoff from Local Development

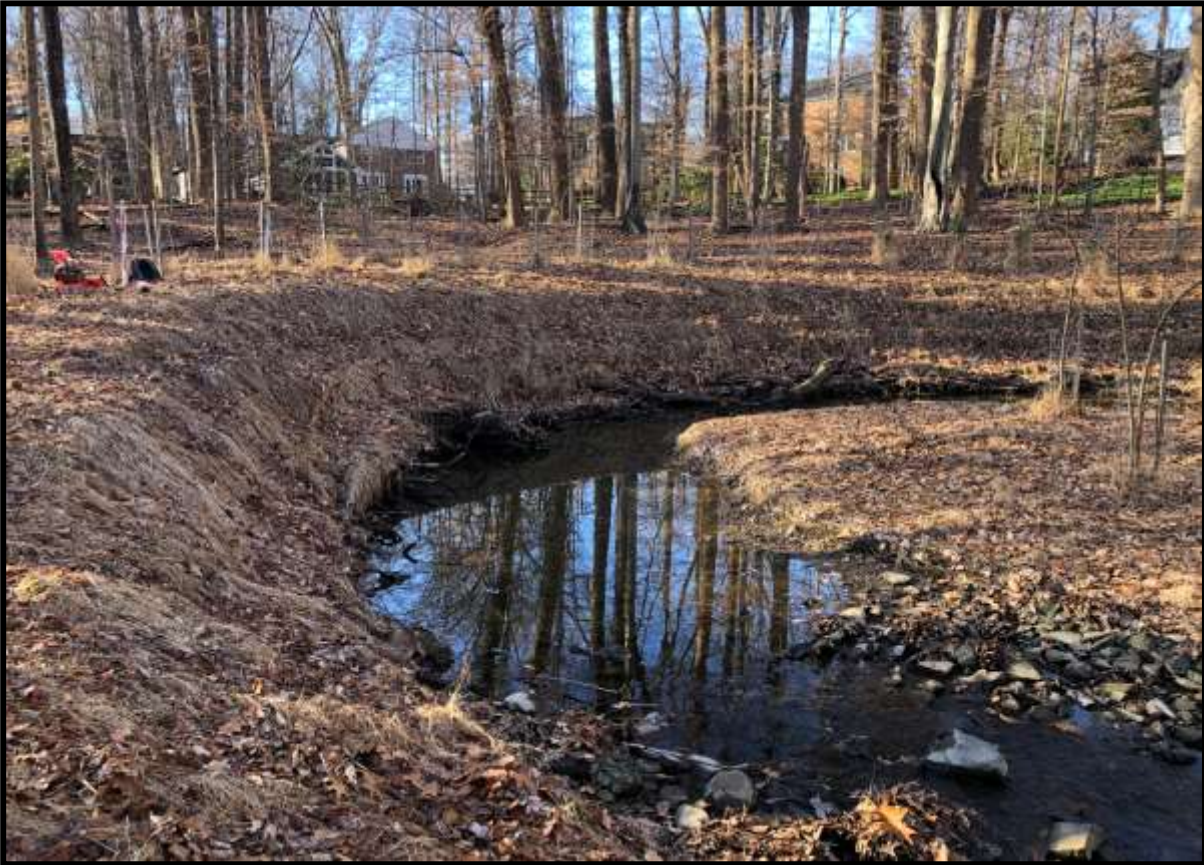
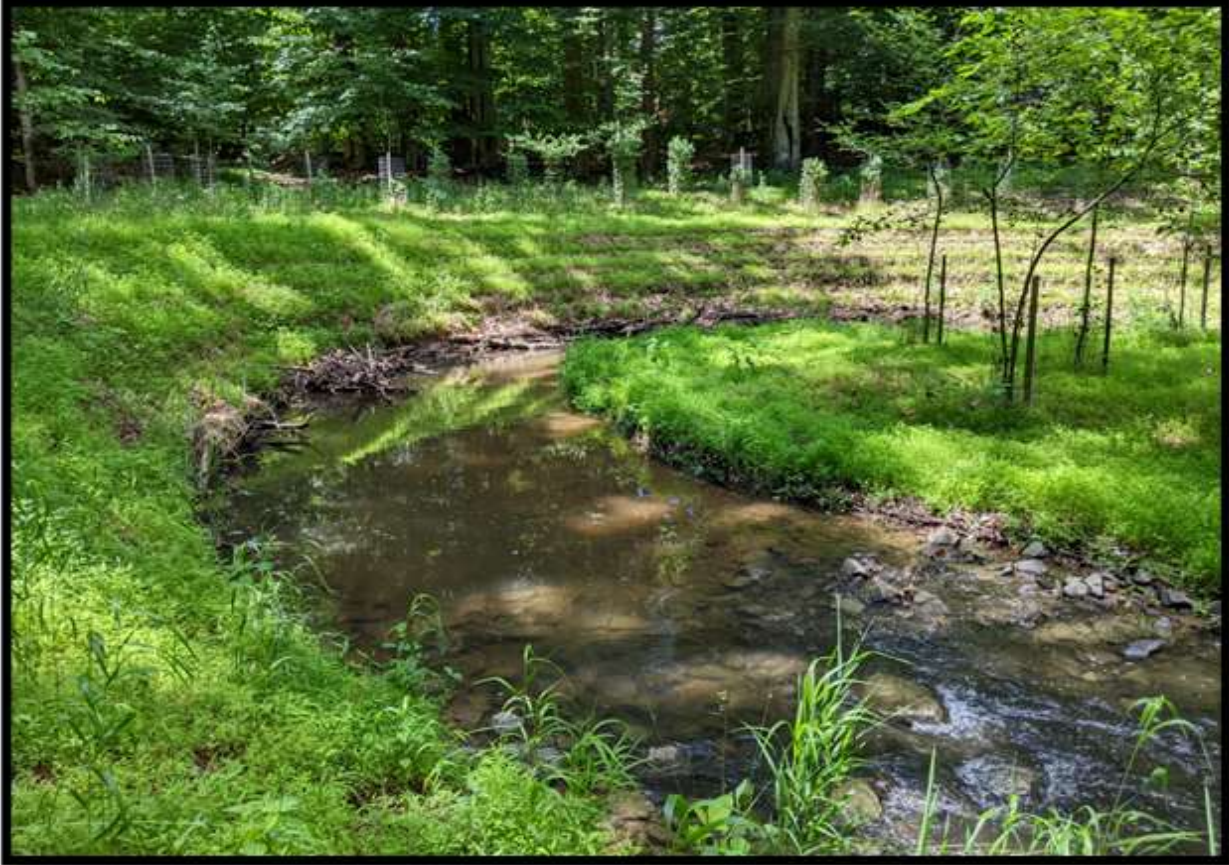
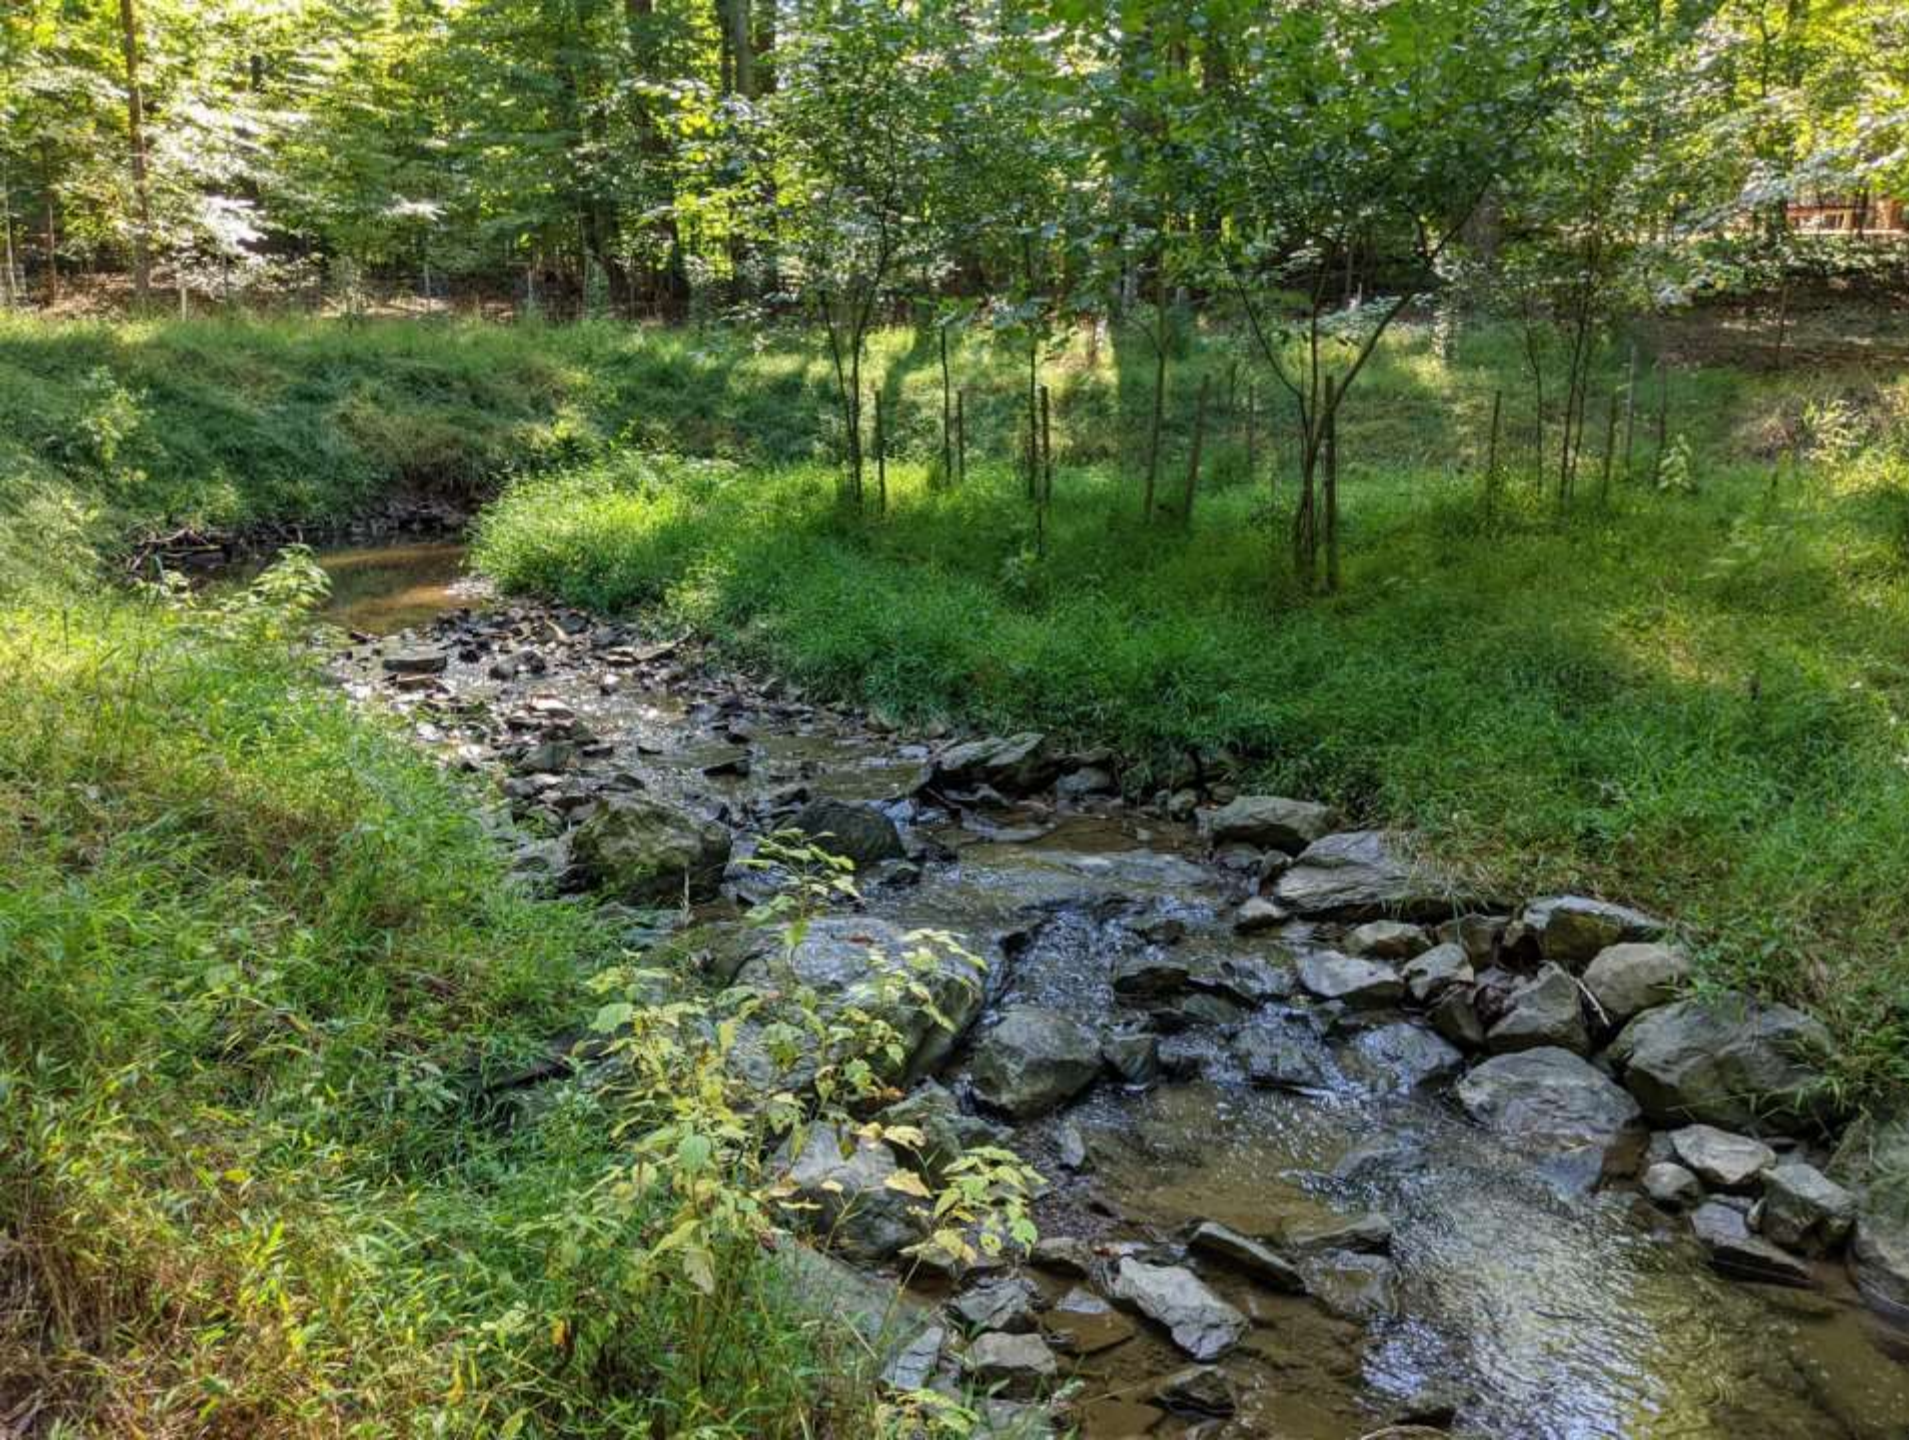
Upper Watts Branch Stream Post-Construction

- Upper Watts Branch Remains Perennial
- Stream is Vertically and Laterally Stable
- Percent Vegetative Cover is 90%
- Success with Planted Red Fescue (*Festuca rubra*), American Sycamore (*Platanus occidentalis*), and Soft Rush (*Juncus effusus*)
