Building a Long-Term Stewardship Program to Manage and Maintain Urban Stream Improvement and Wetland Projects

Beca Deal

City of Charlotte Storm Water Services

August 22, 2023

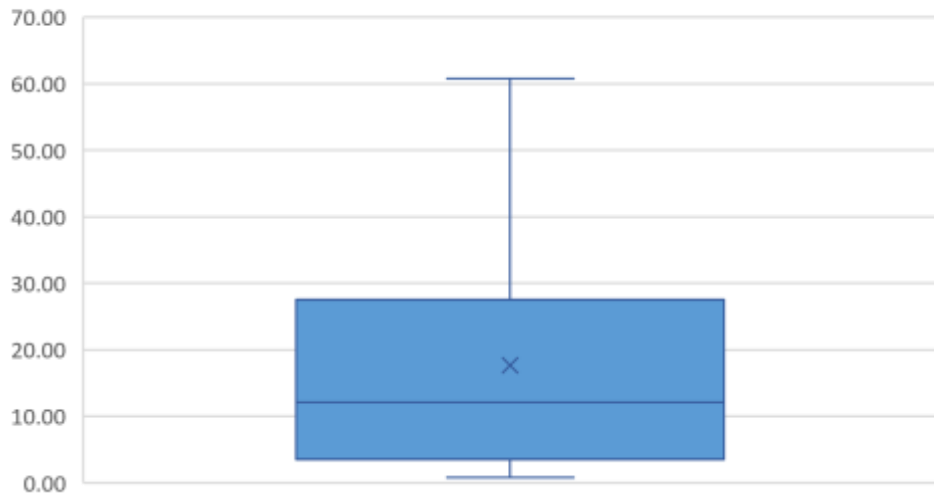
Stream CE Area (Acres)

Majority of stream projects have conservation areas less than 30 acres and are greater than 10 years old.

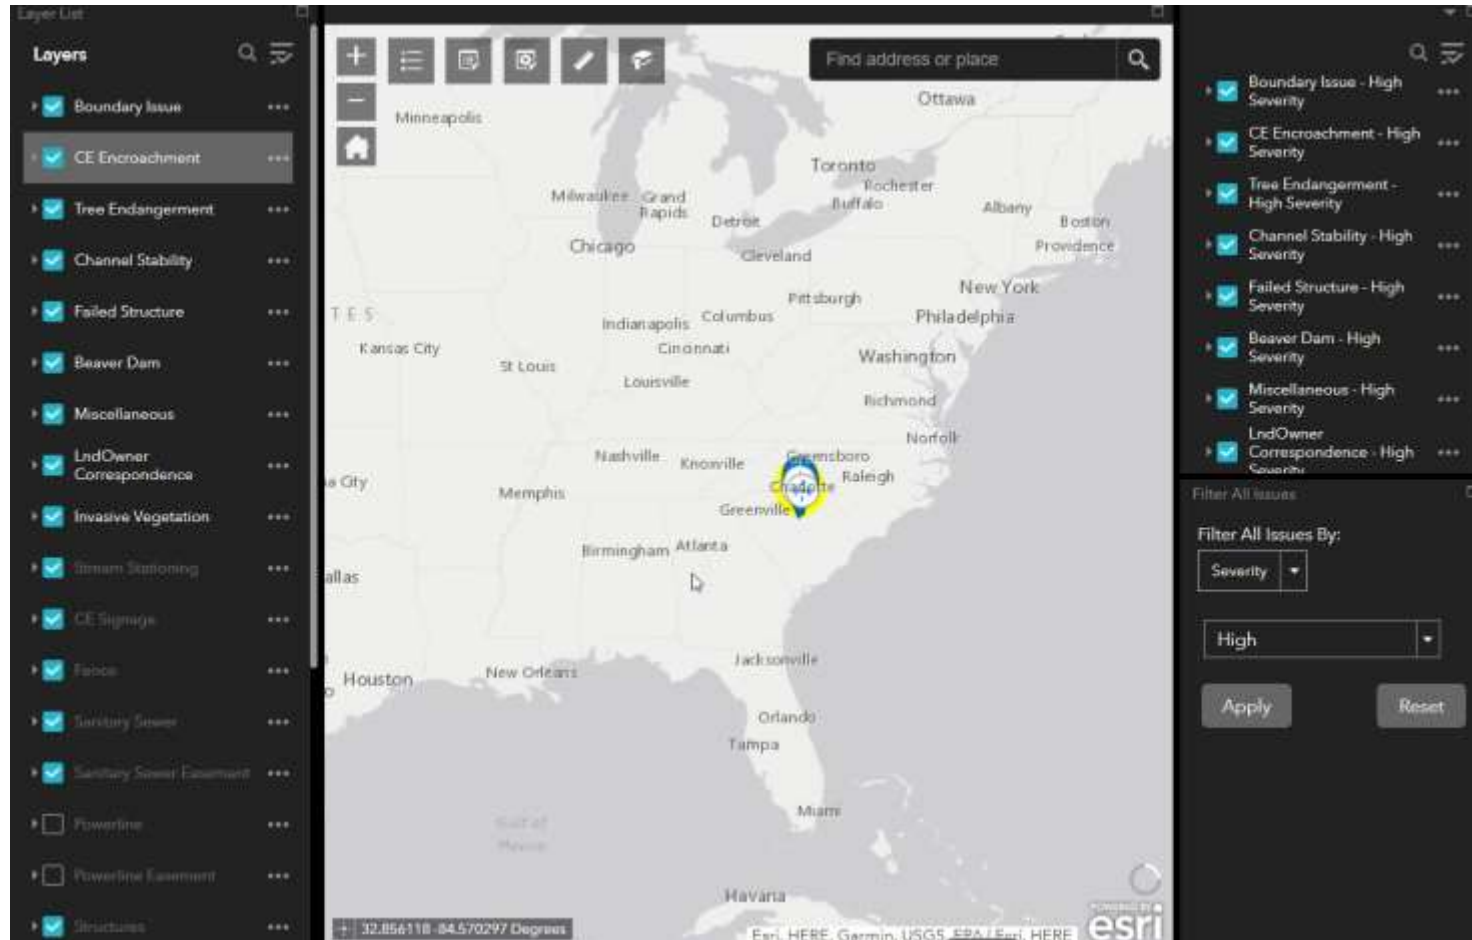
Stream Inspections – ArcGIS Online

- ▽ Conducted annually utilizing ArcGIS Online.
- ▽ Easement boundaries are inspected in late fall and winter. Riparian vegetation is inspected in the late spring early summer.
- ▽ Goal of annual inspections for each project.
- ▽ A minimum of two team members per inspection is recommended for safety purposes.
- ▽ **Developed Inspection SOP**
 - Preparing for the inspection
 - Inspection procedure
 - Collection feature and severity level descriptions
 - Post inspection procedures
 - Example report

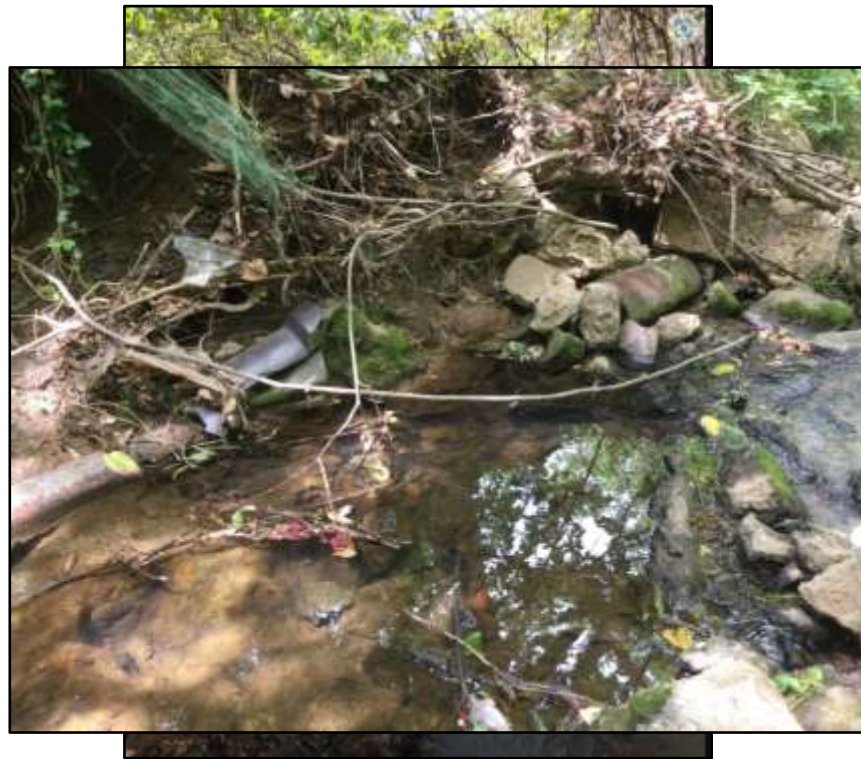
Total issues noted during inspections

Issue Category	Count
Boundary Issue	62
CE Encroachment	238
Tree Endangerment	185
Channel Stability	236
Failed Structure	154
Beaver Dam	33
Miscellaneous	73
LnOwner Correspondence	0
Invasive Vegetation	184

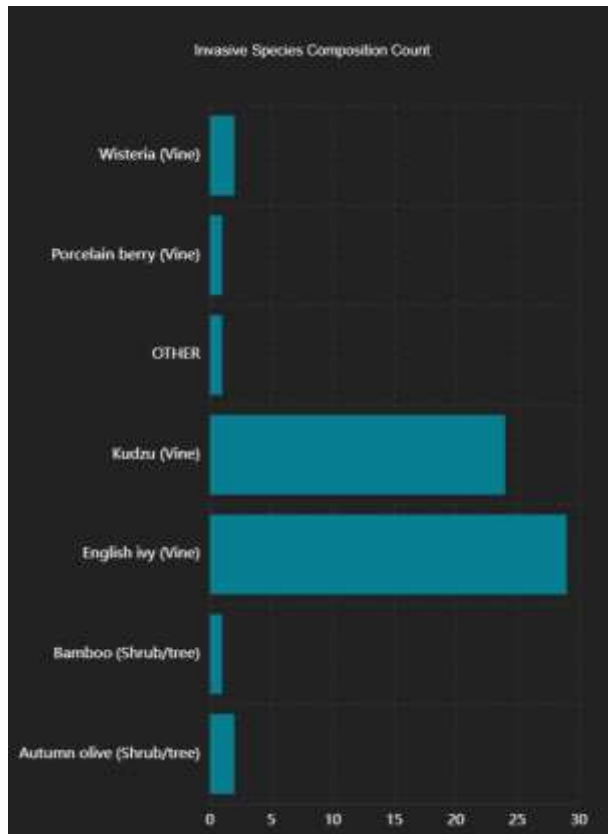
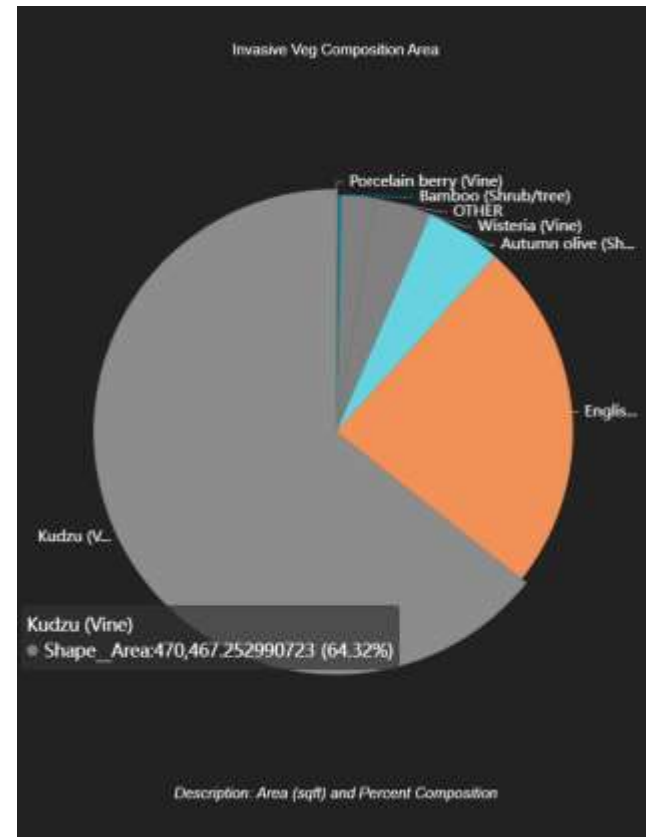
Invasive species issues noted as being high severity

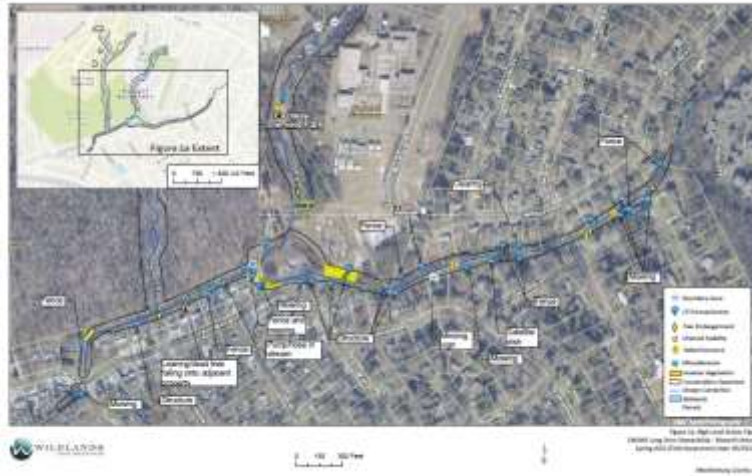
- ◊ Project background / introduction
- ◊ Inspection summary
- ◊ High severity issues
- ◊ Field map noted with high severity issues

LONG TERM STEWARDSHIP
MONITORING REPORT

The following report provides a summary of site conditions observed during the current inspection and highlights high level action items. Detailed inspection notes and photographs are available geospatially in the City of Charlotte L-TS web map (link above).

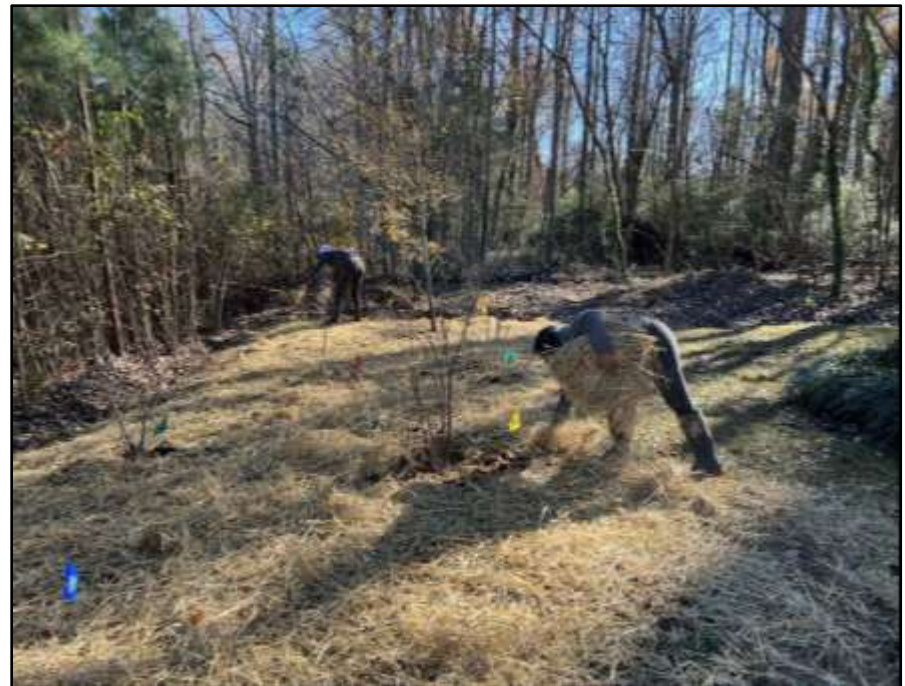
Replanting a CE after property owner mowed and cut back vegetation
