Aquatic Resource Mitigation at Bensalem Township High School

AUGUST 2023

PRESENTED TO: National Stream Restoration Conference

PennDOT District 6-0, S.R. 0001, Group 03S, Sections RC1 & RC2

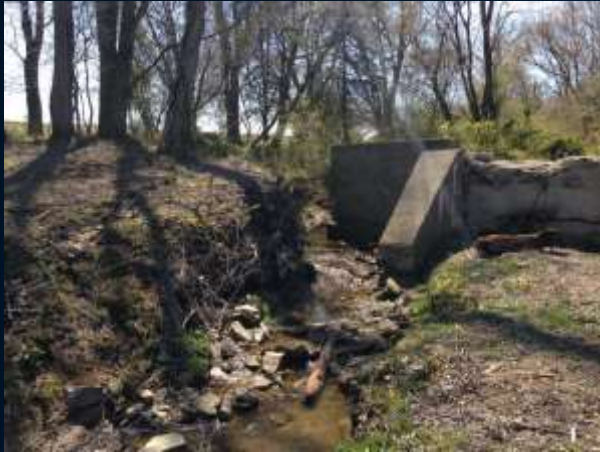
- Breached Primary Dam

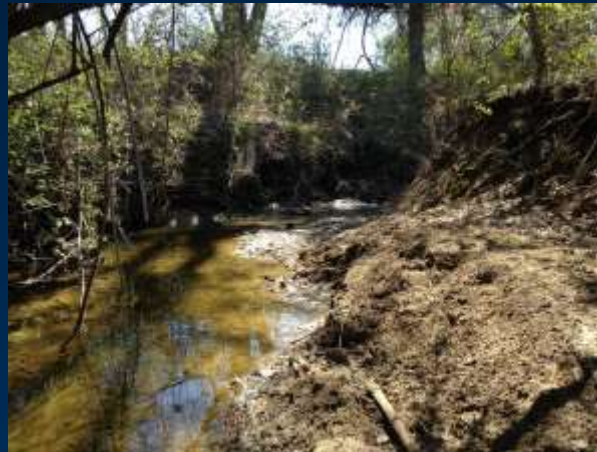
- Severely entrenched

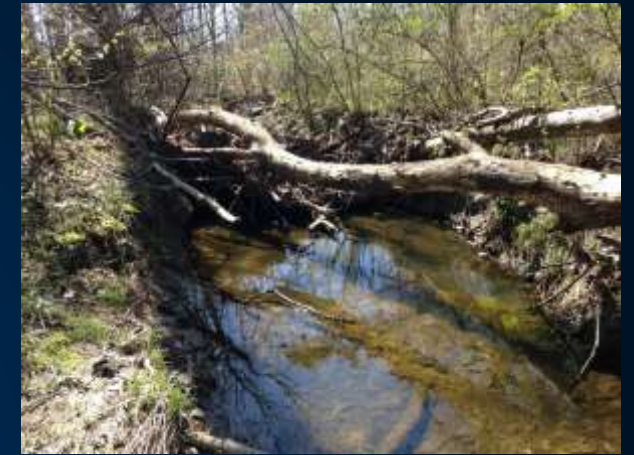
- Debris jams from fallen trees

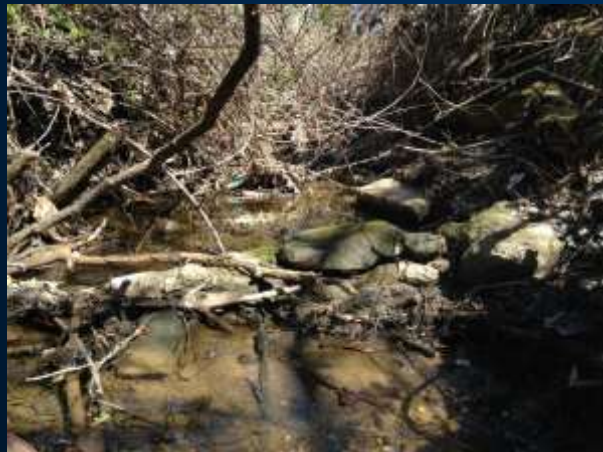
- Breached Secondary Dam

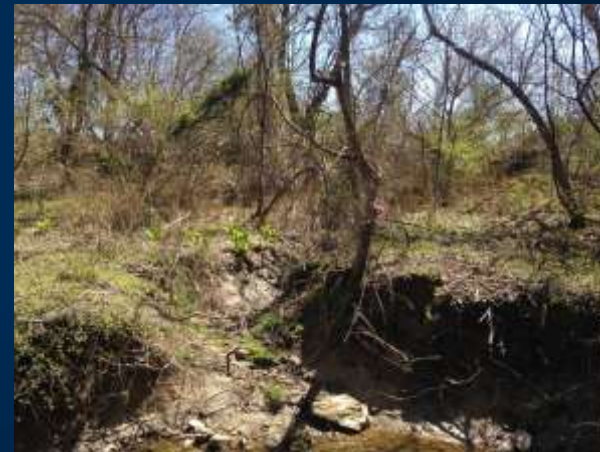
- Draining perched wetlands

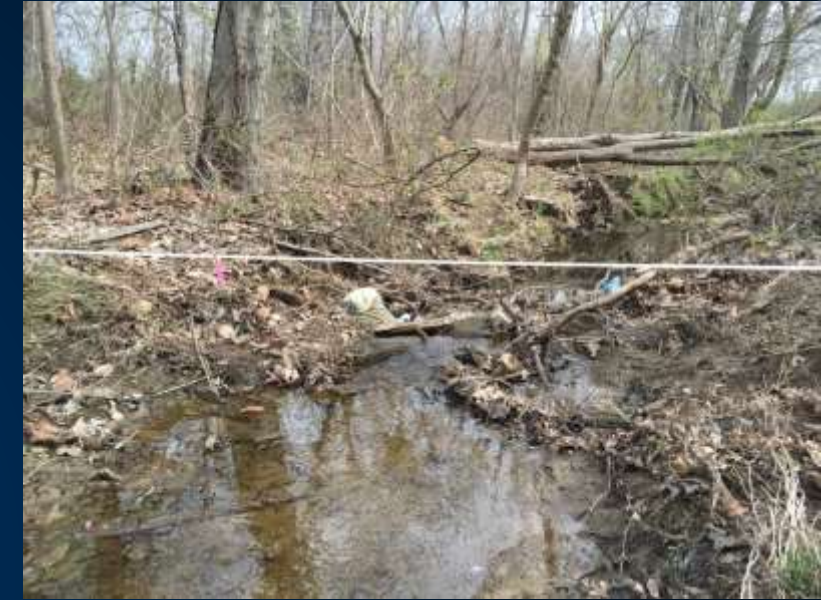
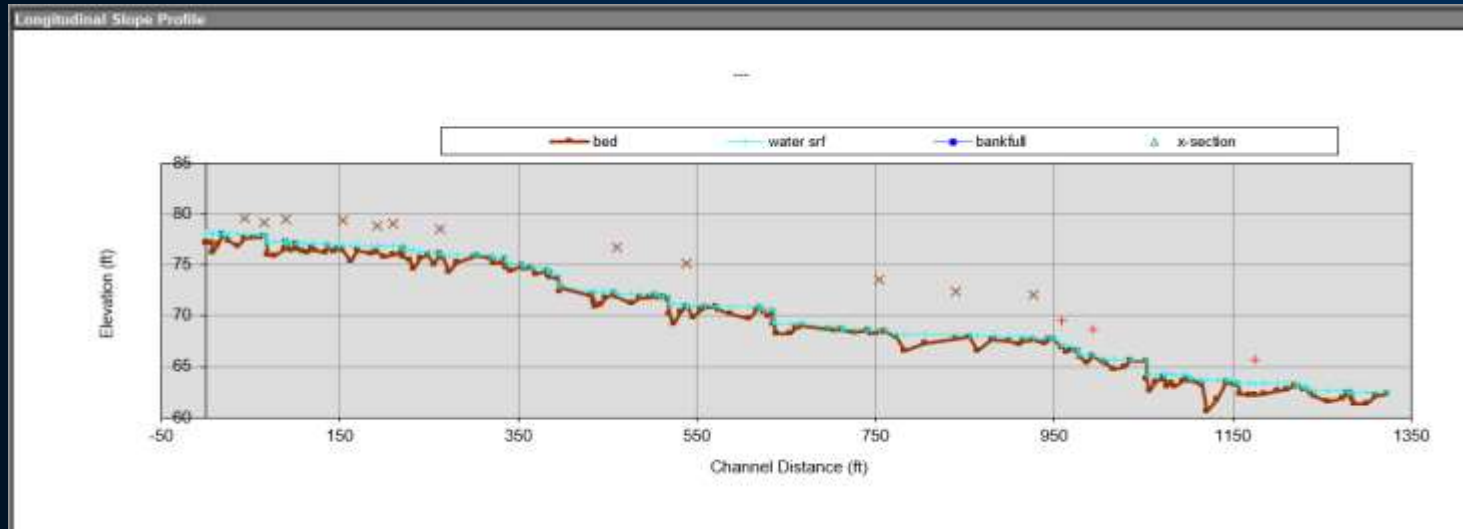
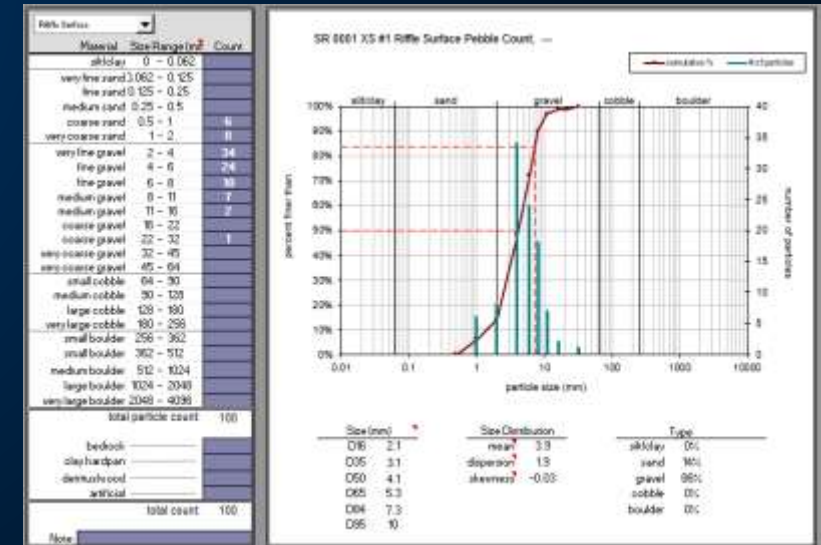
Geomorphic Assessment

- Characterize Existing Stream Conditions

- Stream Type
- Entrenchment Ratio
- Cross-Sectional Area
- Channel width
- Mean depth
- Substrate Analysis
- Longitudinal Profile

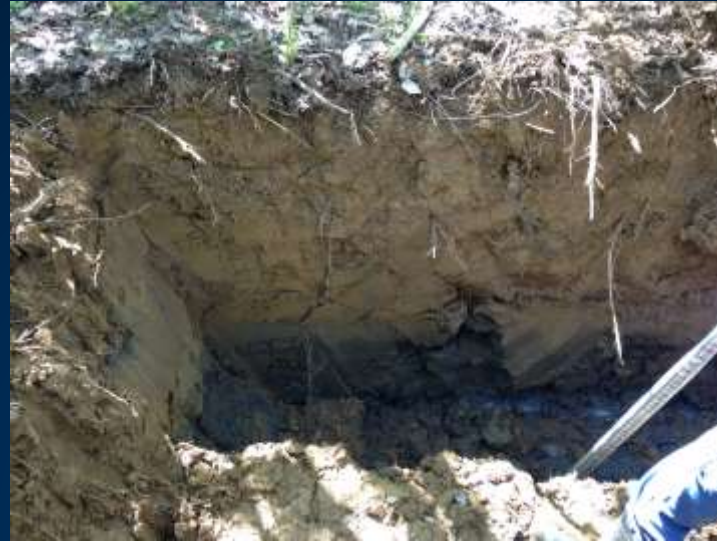
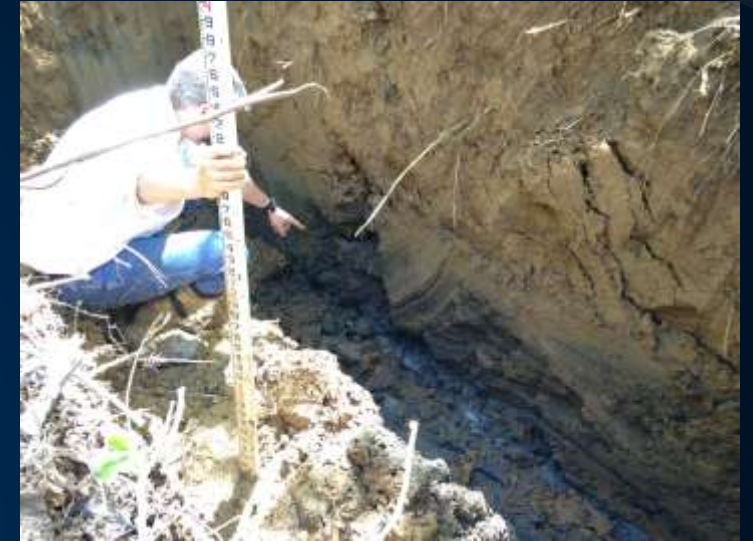
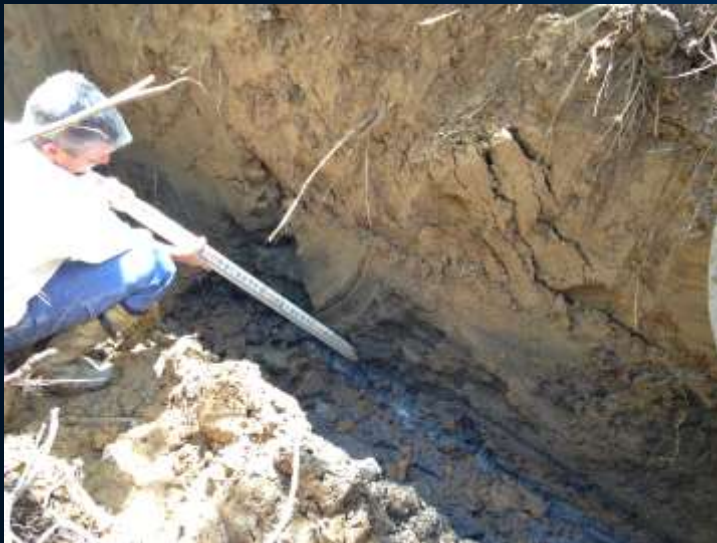
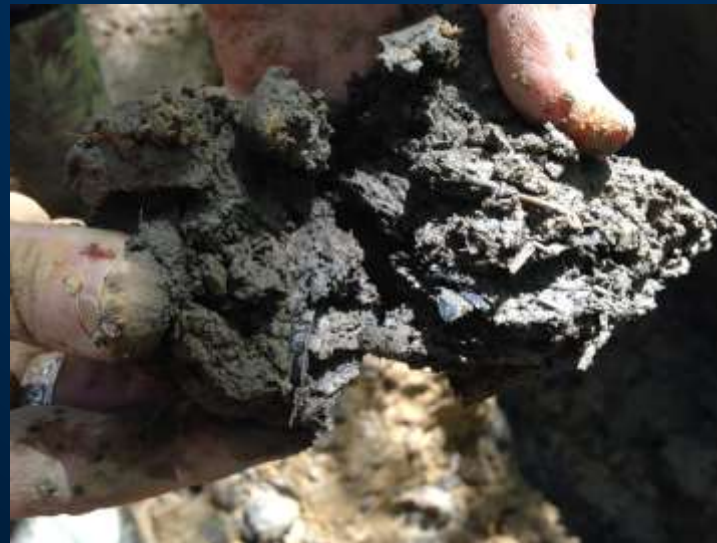
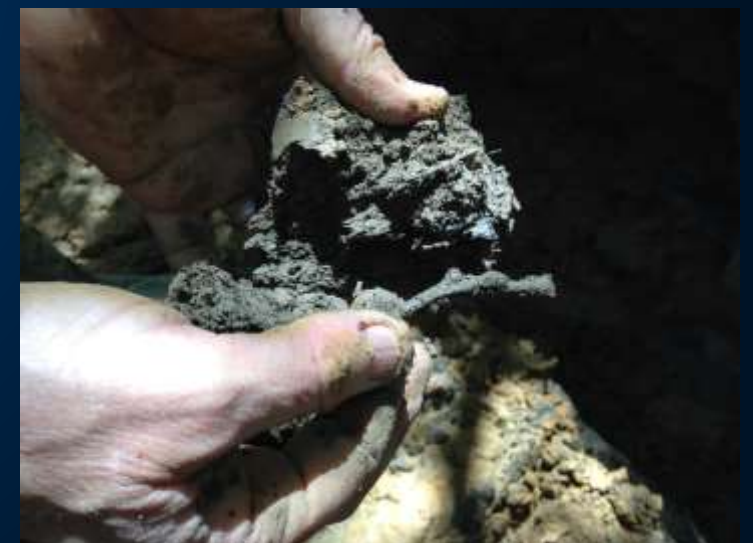
Trench Investigation

- Characterize Soil Profile

- Soil Types
 - Clay, loam, sand, silt
- Hydric Soils
- Red/Ox Conditions
- Soil Horizons
 - Depths
 - Thickness
- Soil color

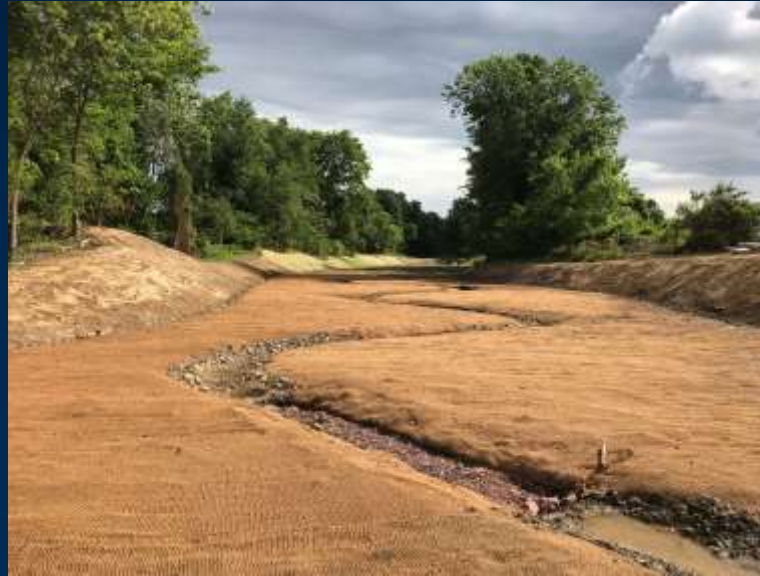
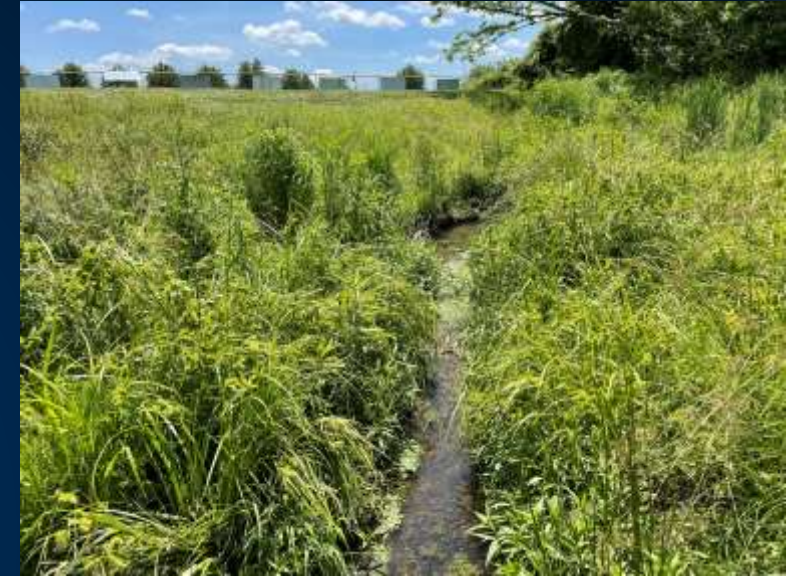
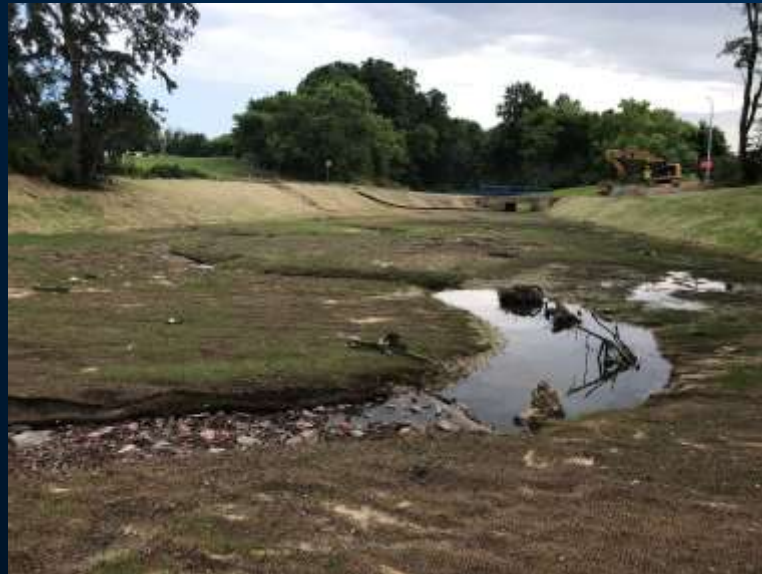
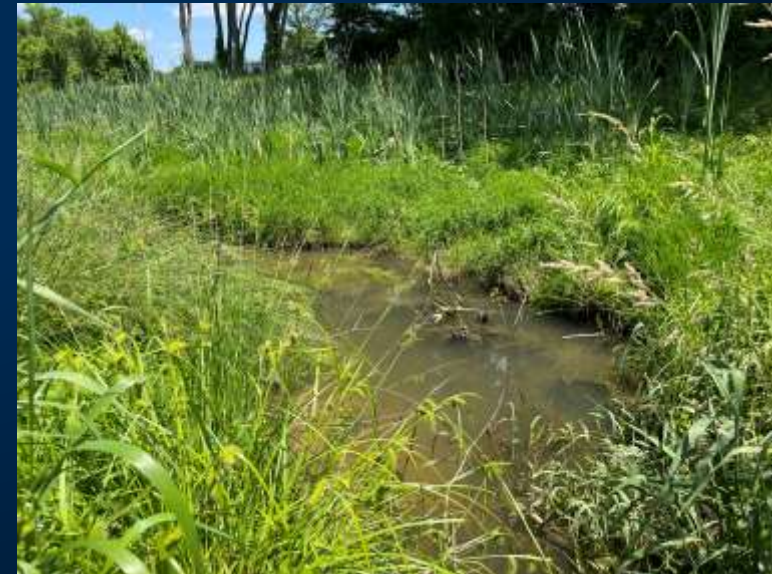
PHOTOS OF DESIGN ELEMENTS

- In-Stream Structures
 - Engineered Riffle
 - Log Sills
 - Toe Wood Structures

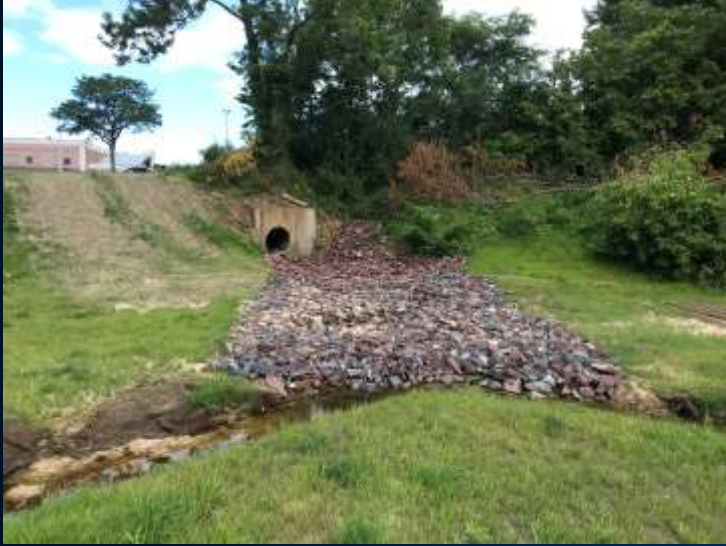
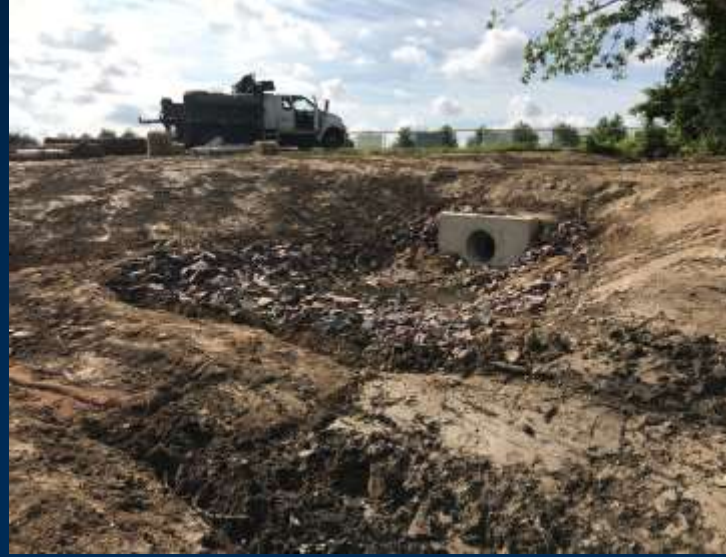
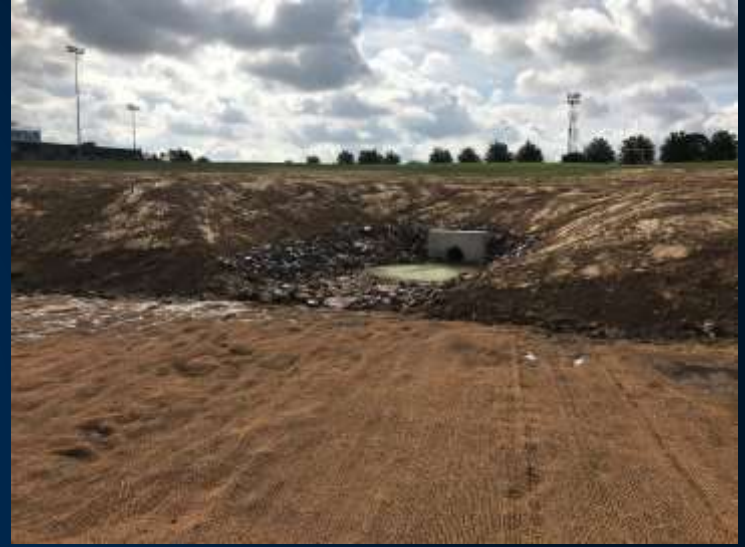
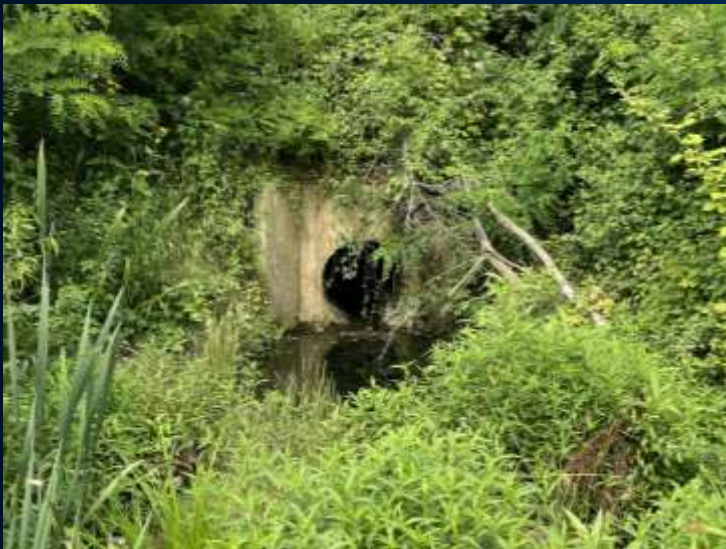
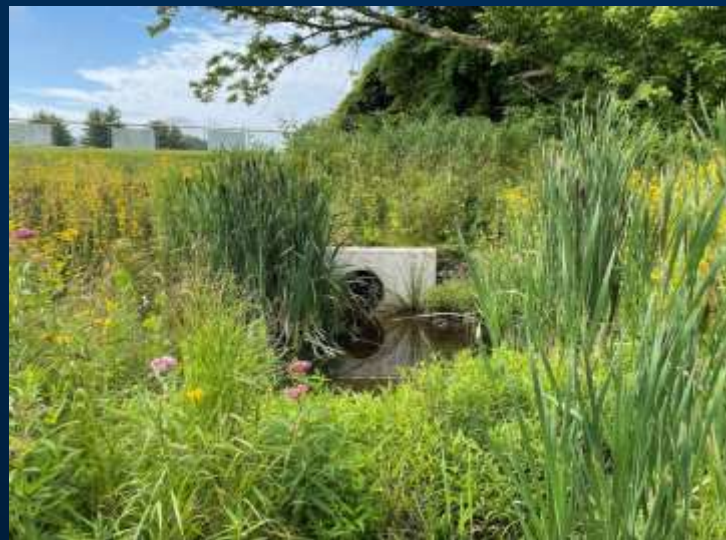
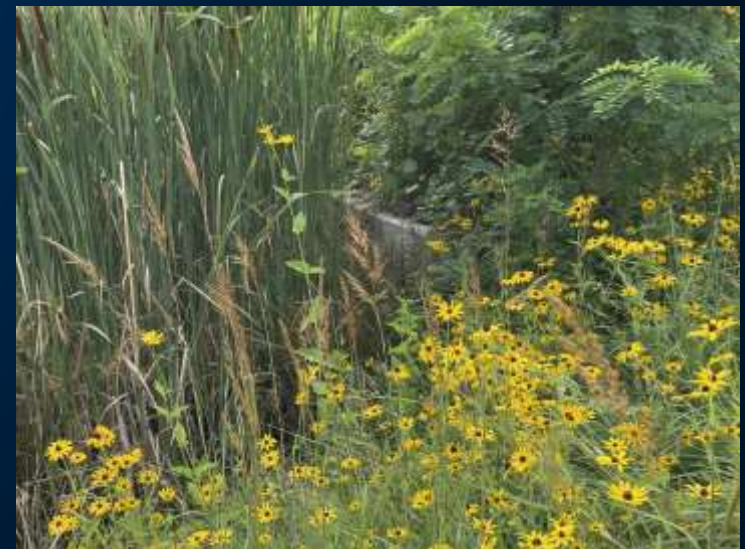
PHOTOS OF DESIGN ELEMENTS

- One Existing and Three New Stormwater Outfalls

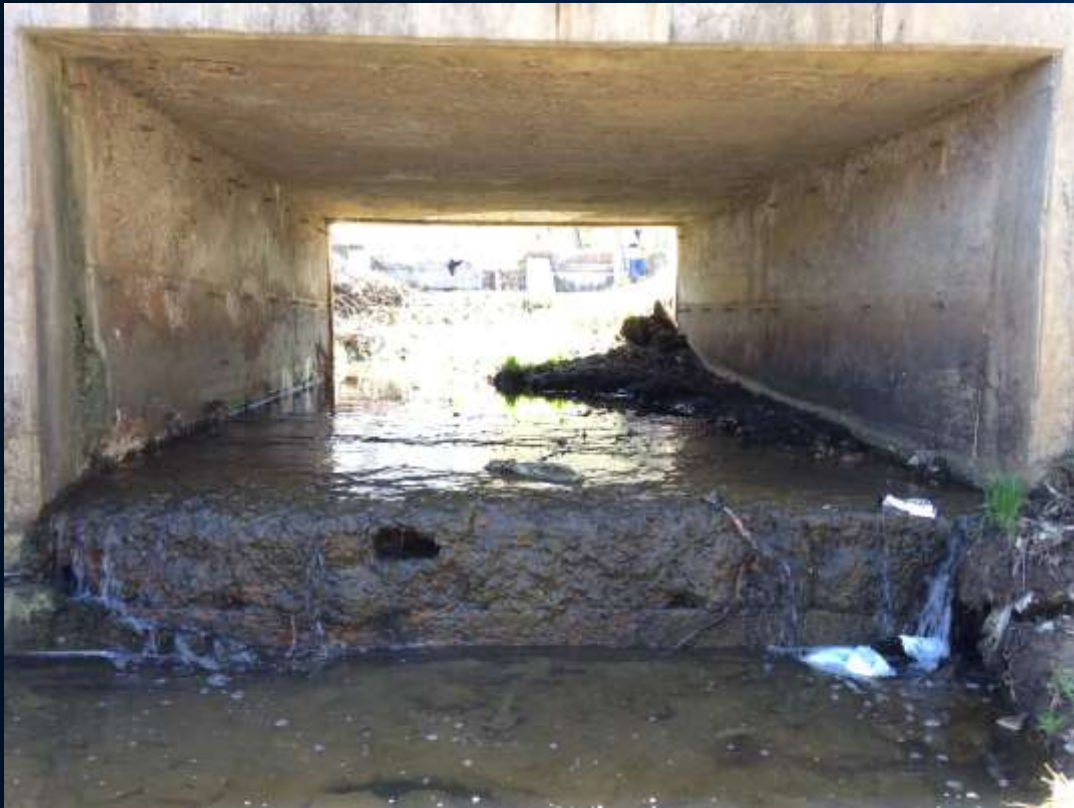
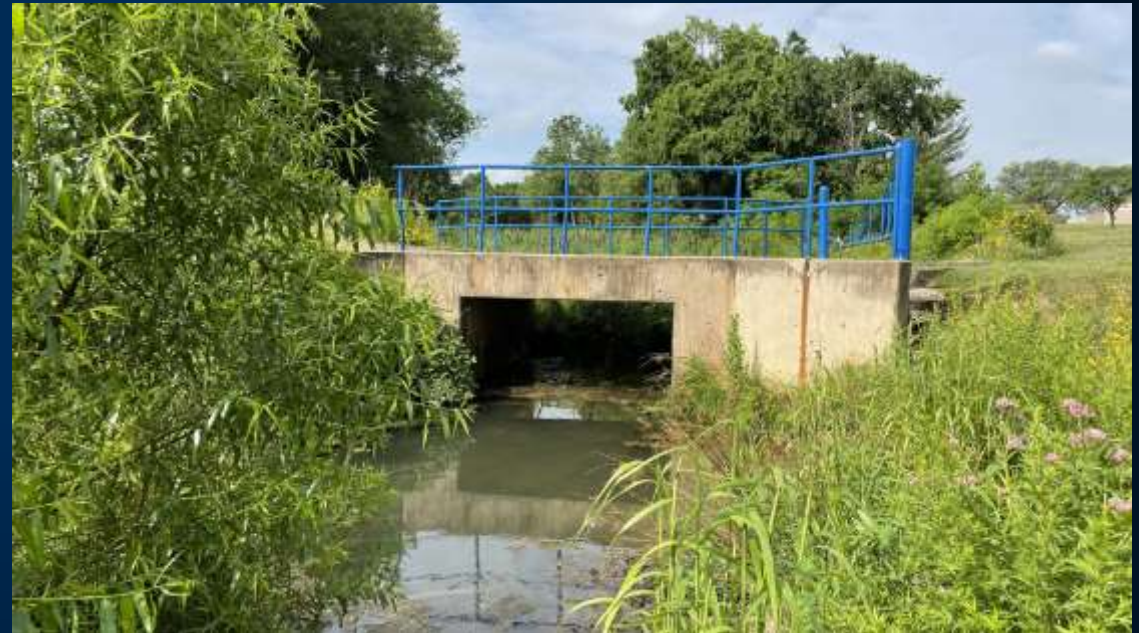
PHOTOS OF DESIGN ELEMENTS

- River continuum and Aquatic Organism Passage (AOP) through existing bridge

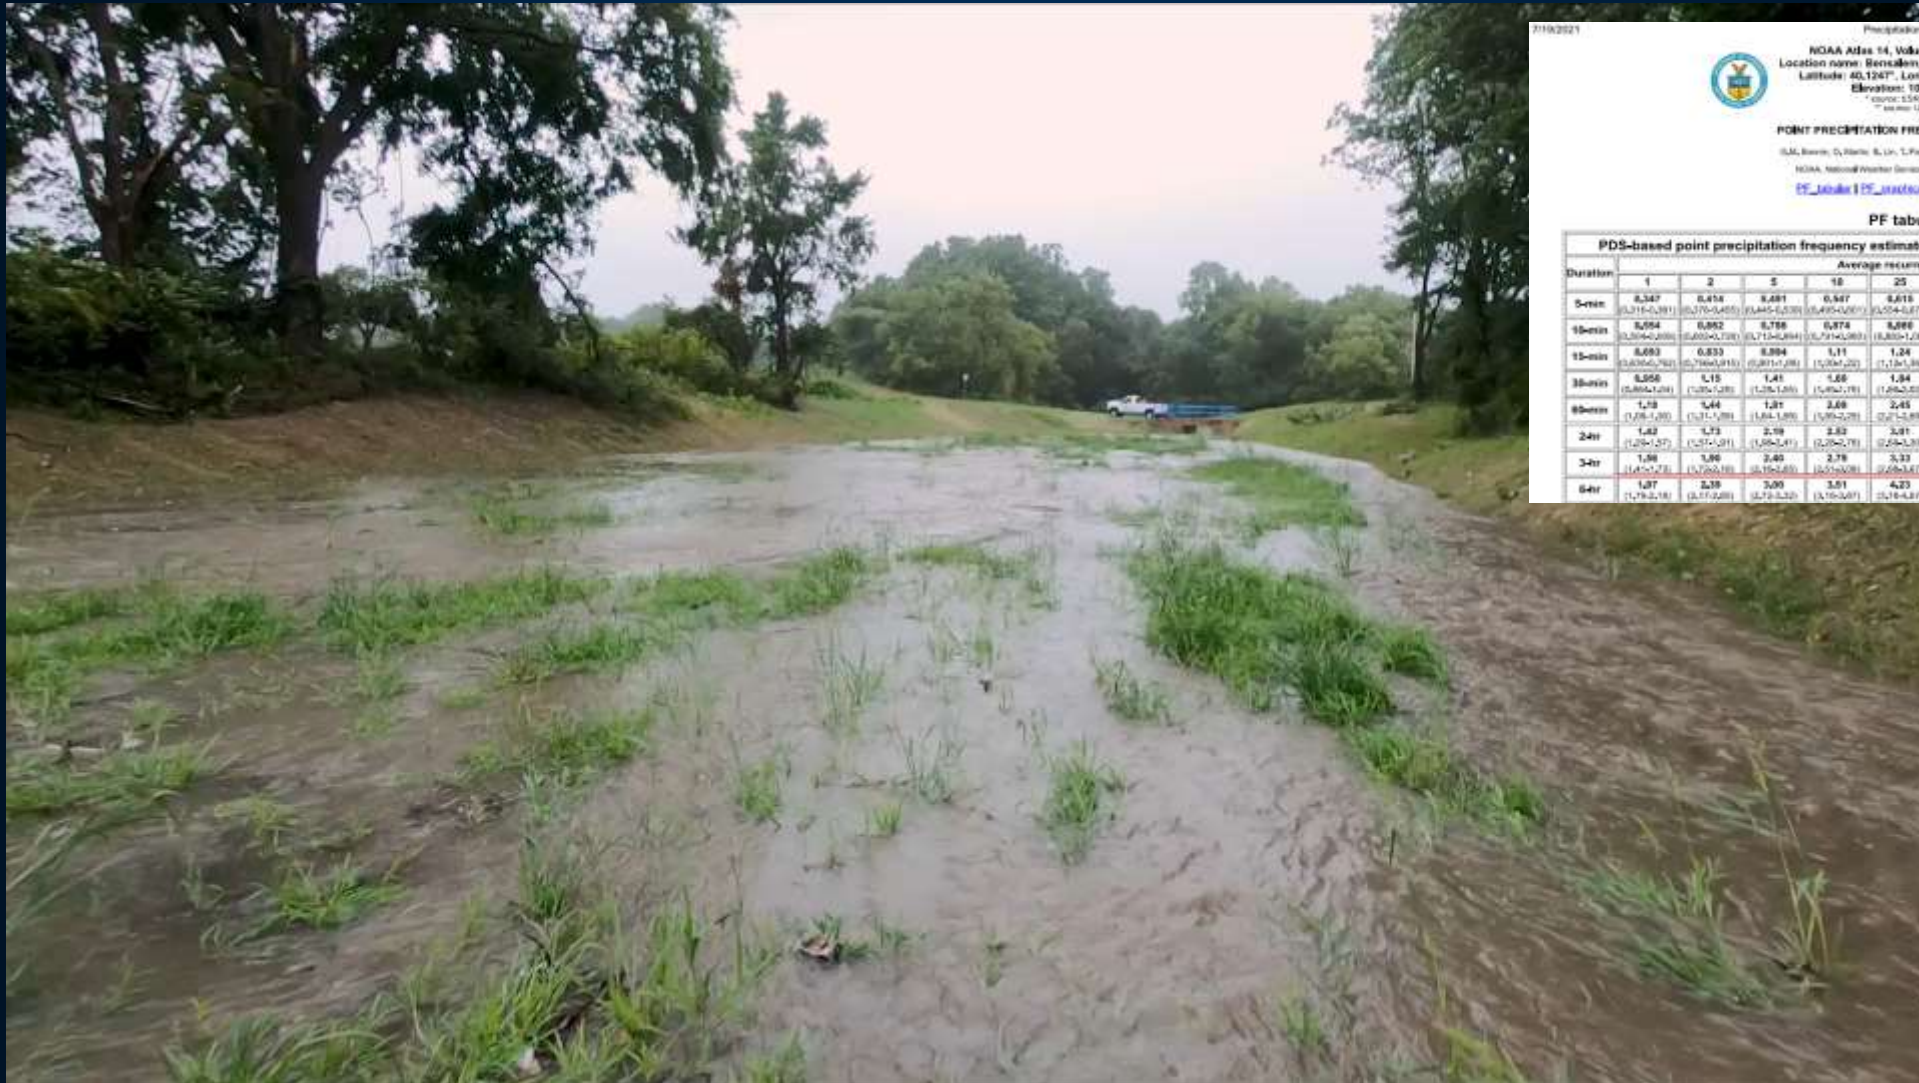
TROPICAL STORM ISAIAS - August 2020

Approximately 2 months after Construction

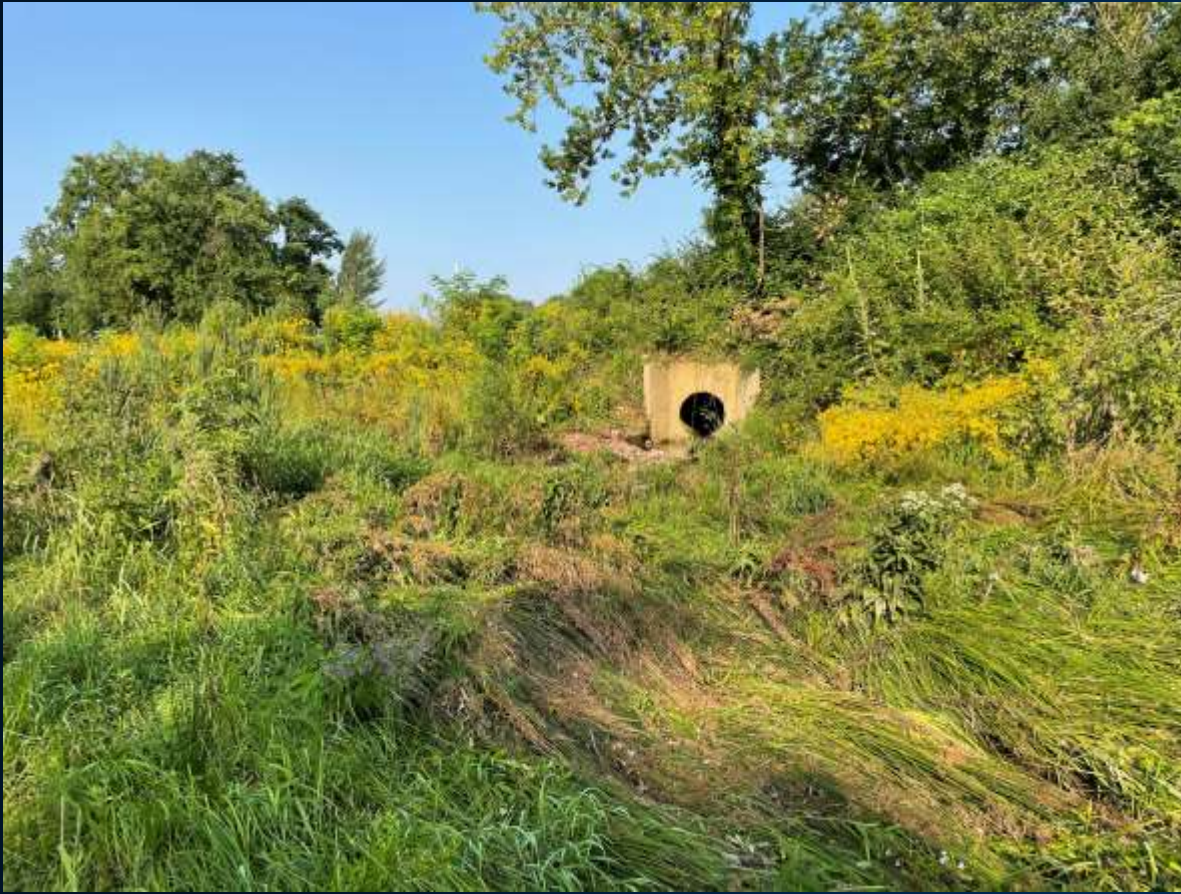
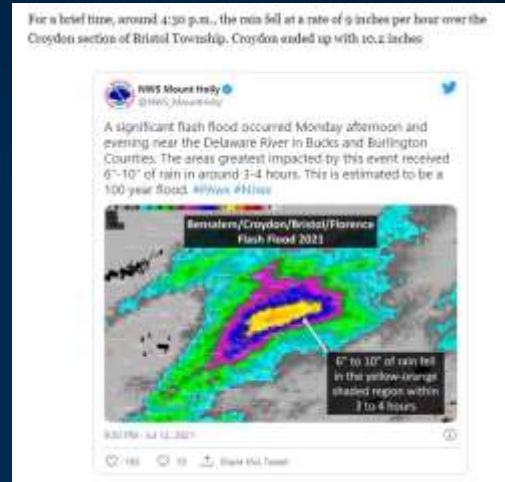
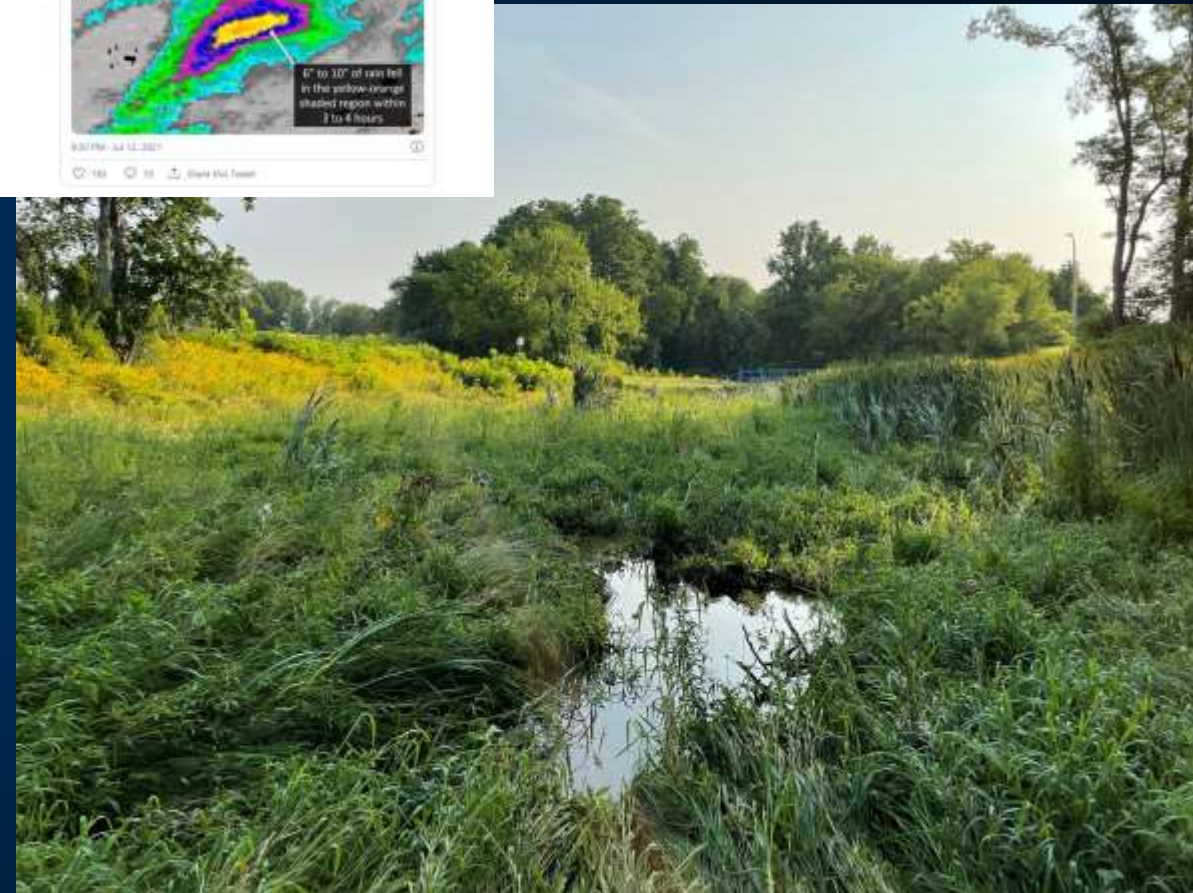
1-Year Post-Construction – Tested Again

- 6.0"-10.0" rain in 3-4 hours
- Greater than the 100-year storm event

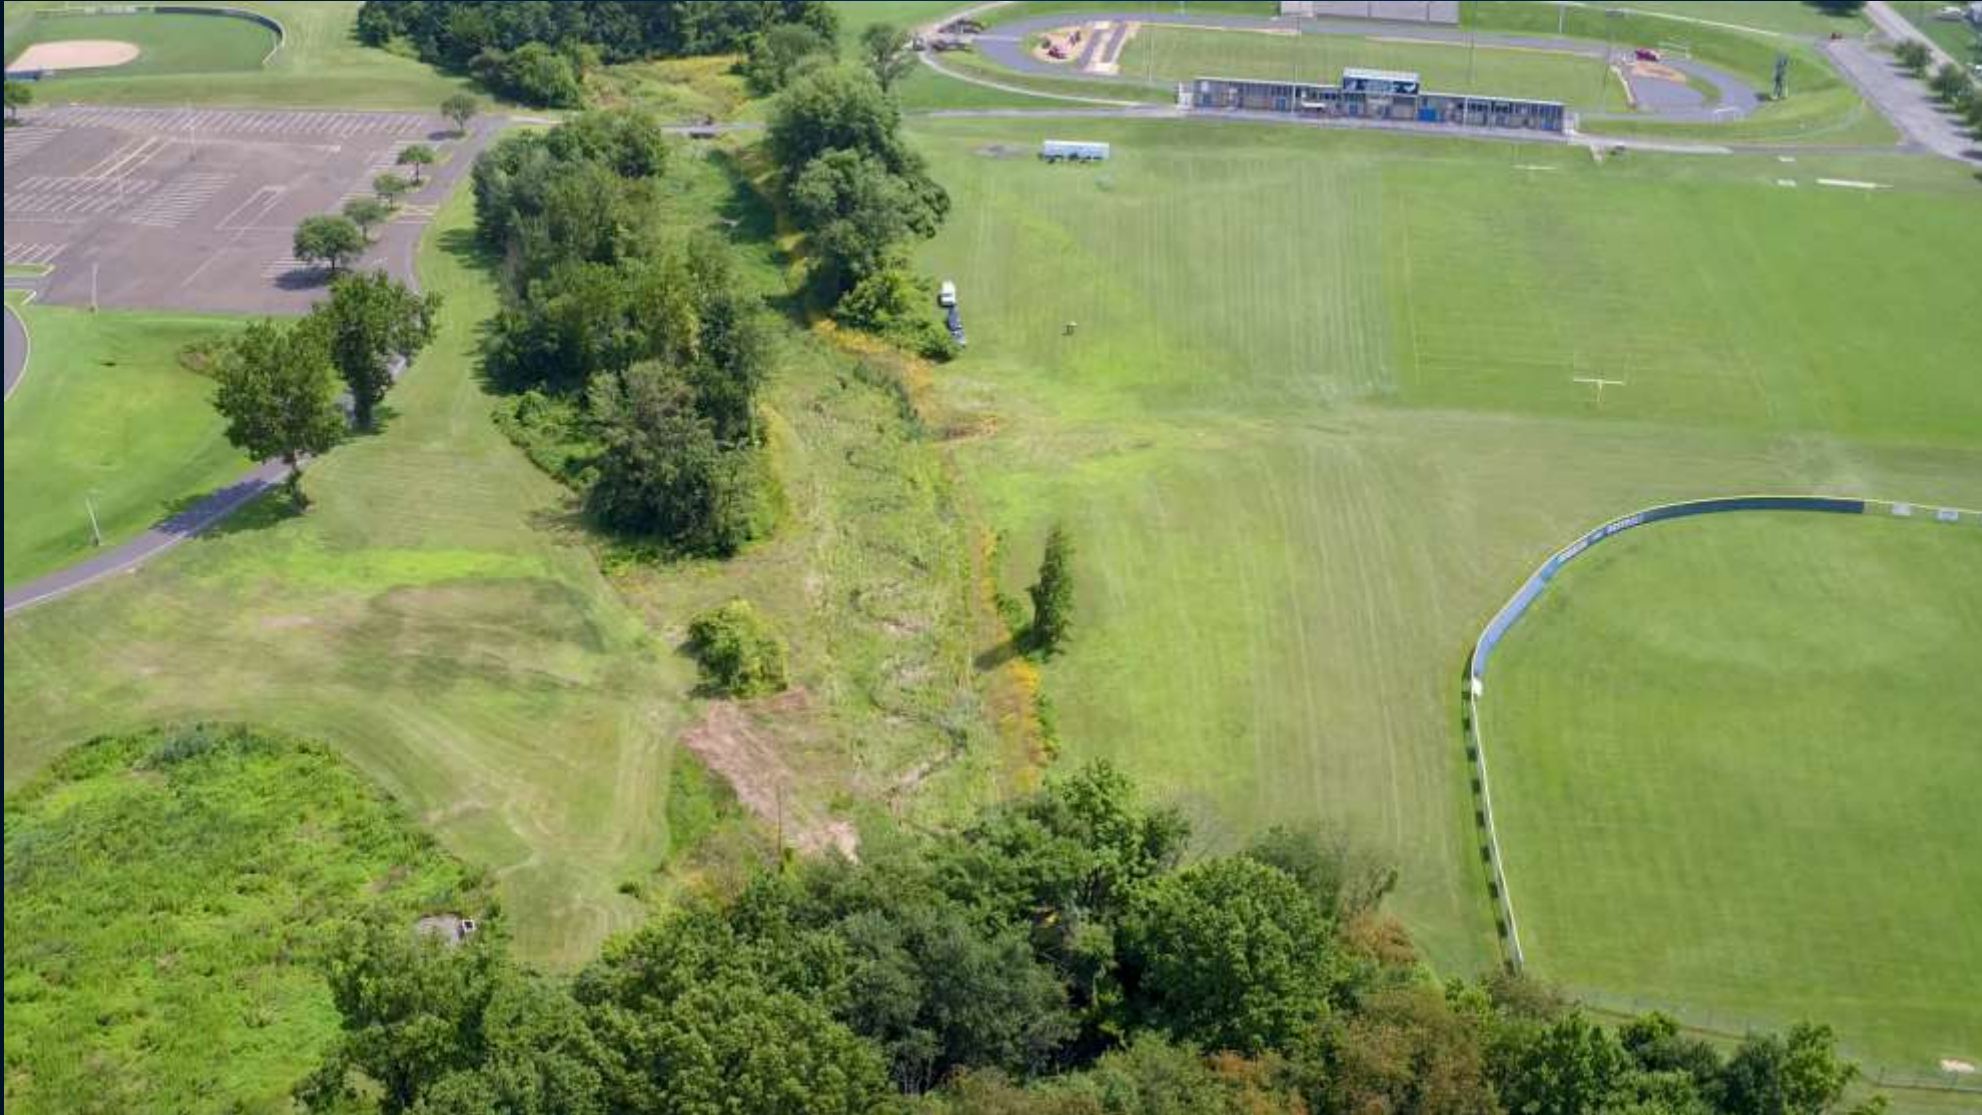
July 22, 2021

One week after 100-Year storm event

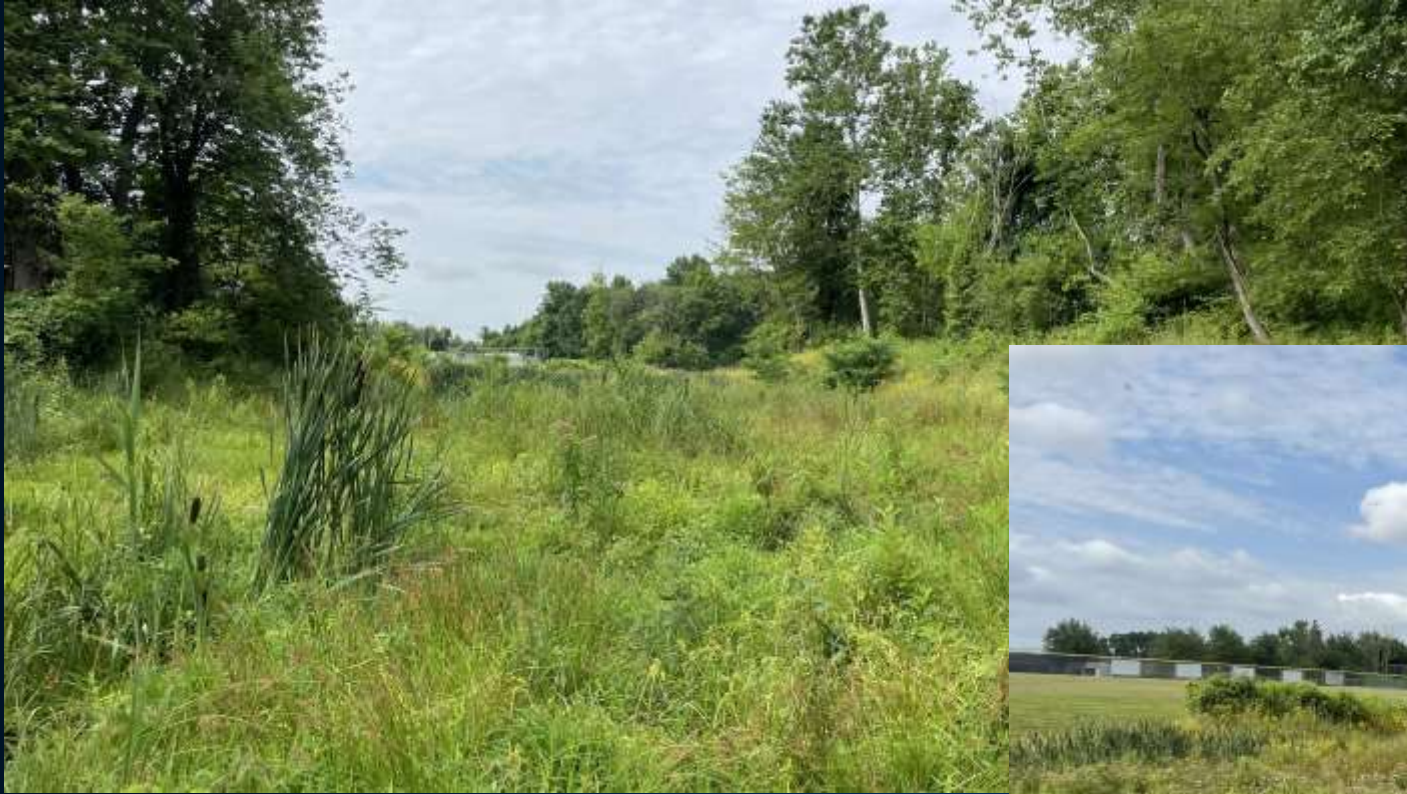
Looking downstream

July 2022 – Two Years Post Construction
