TRACKING TRAJECTORIES OF FULLY CONNECTED FLOODPLAIN LANDSCAPES

Joe Rudolph and Luke Russell - Wolf Water Resources

WHYCHUS CREEK MONITORING

SISTERS, OR

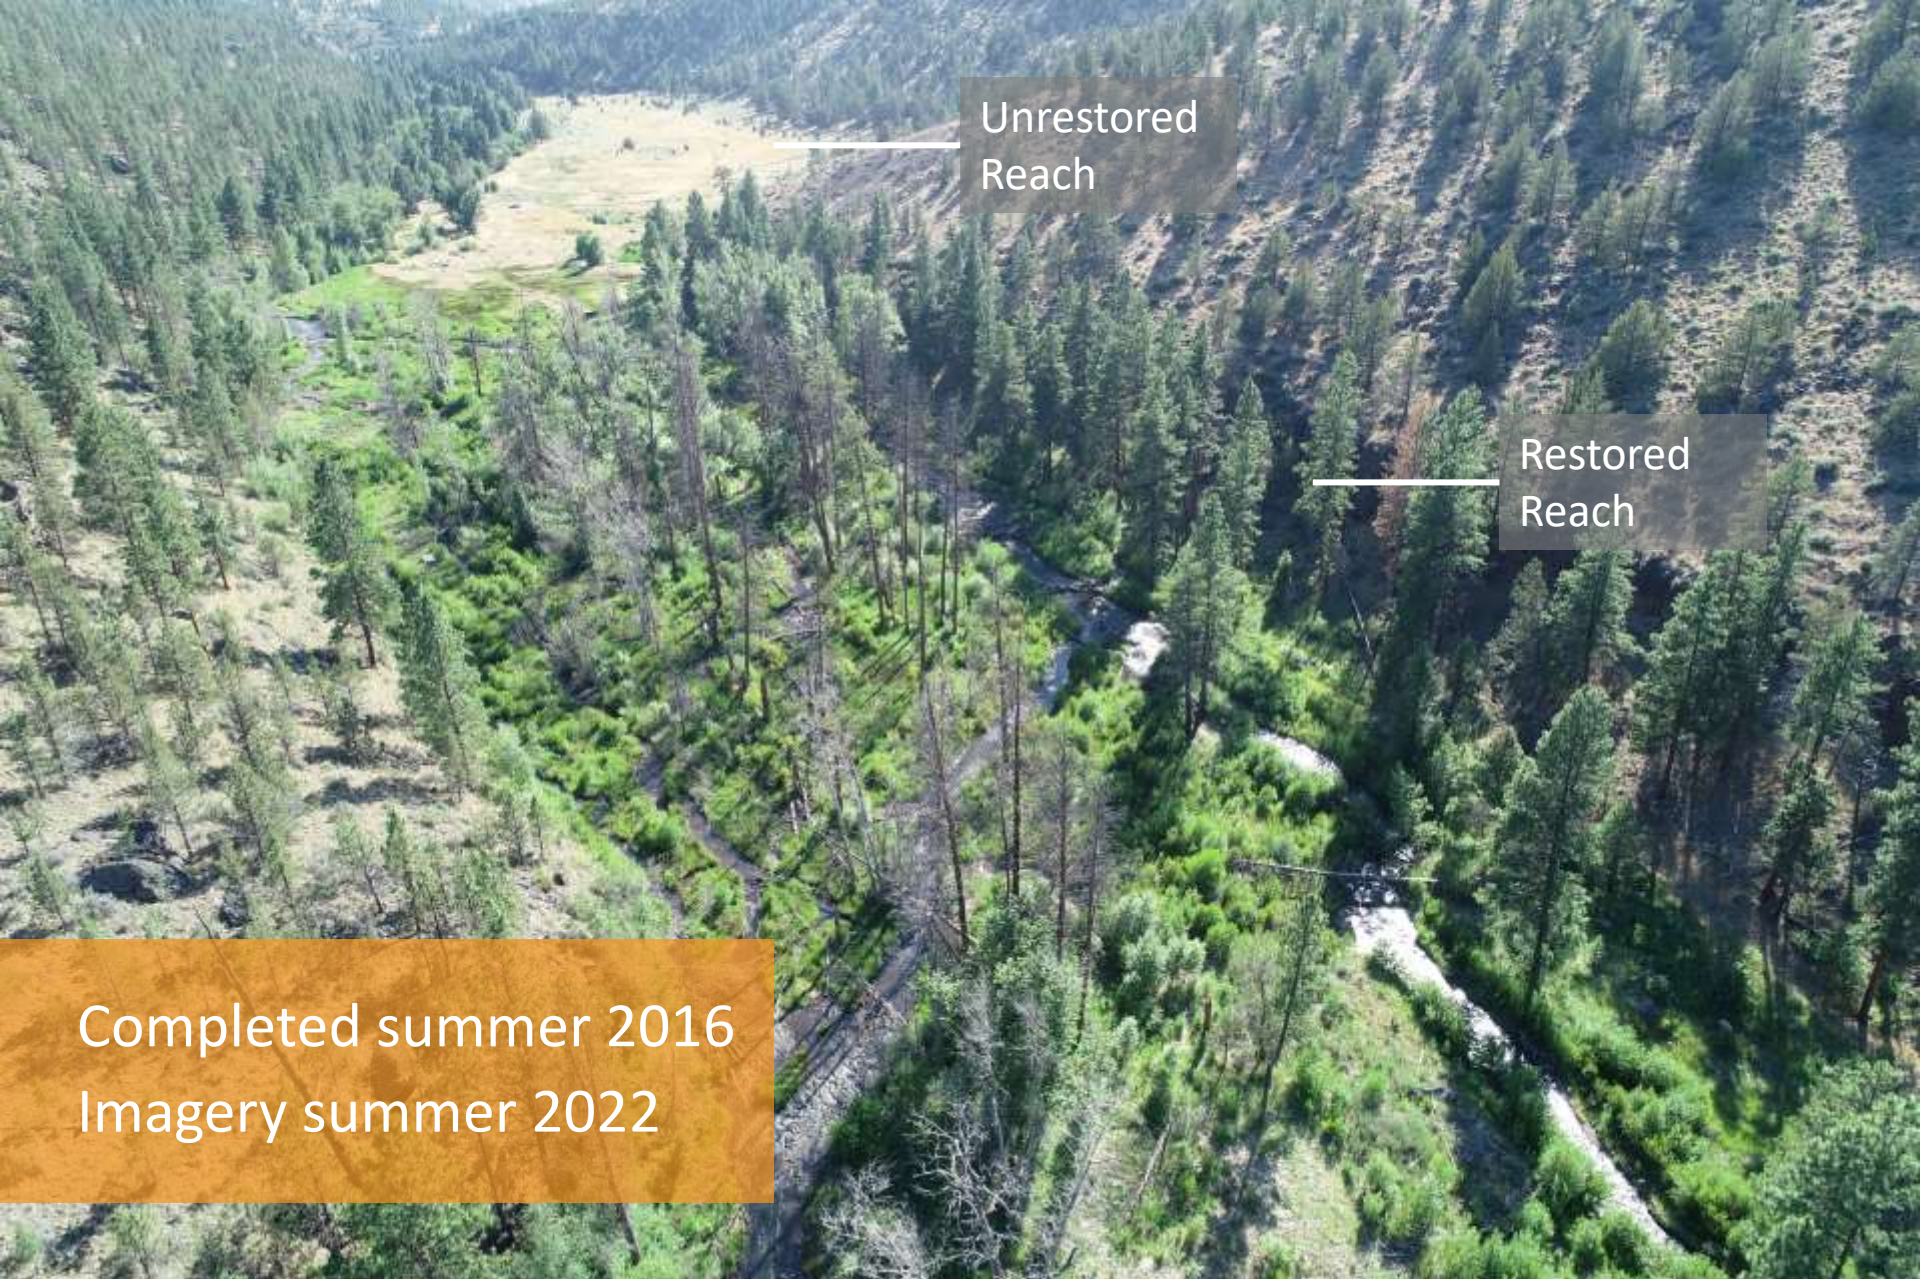
Unrestored
Reach

Restored
Reach

Completed summer 2016
Imagery summer 2022

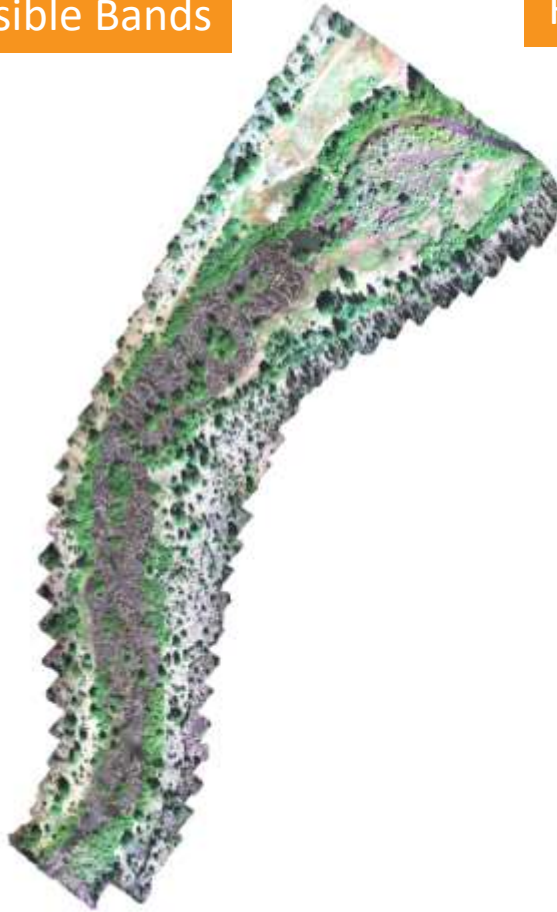
Visible Bands

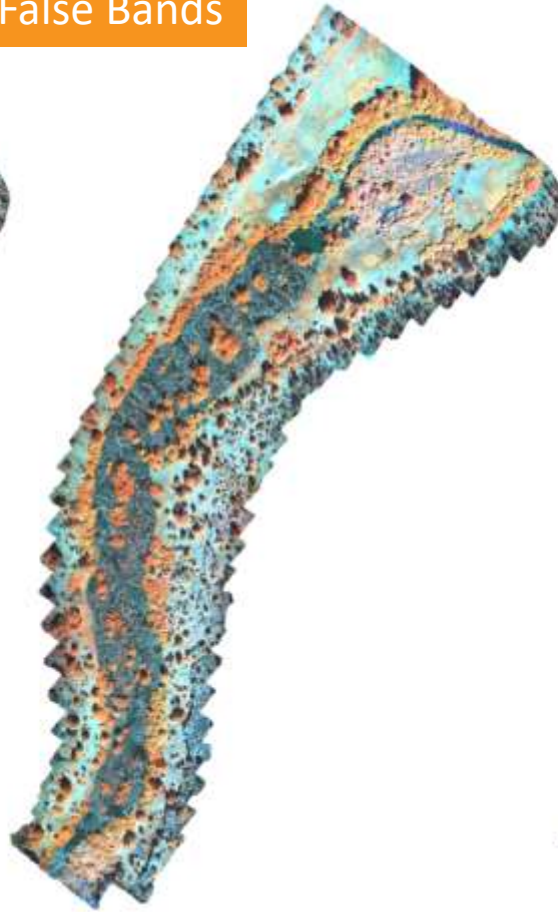
False Bands

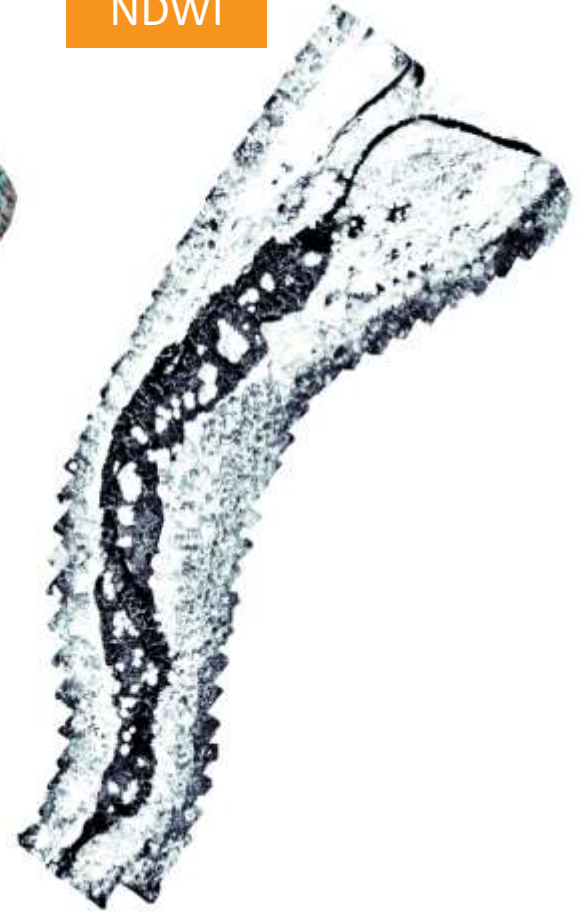
NDWI

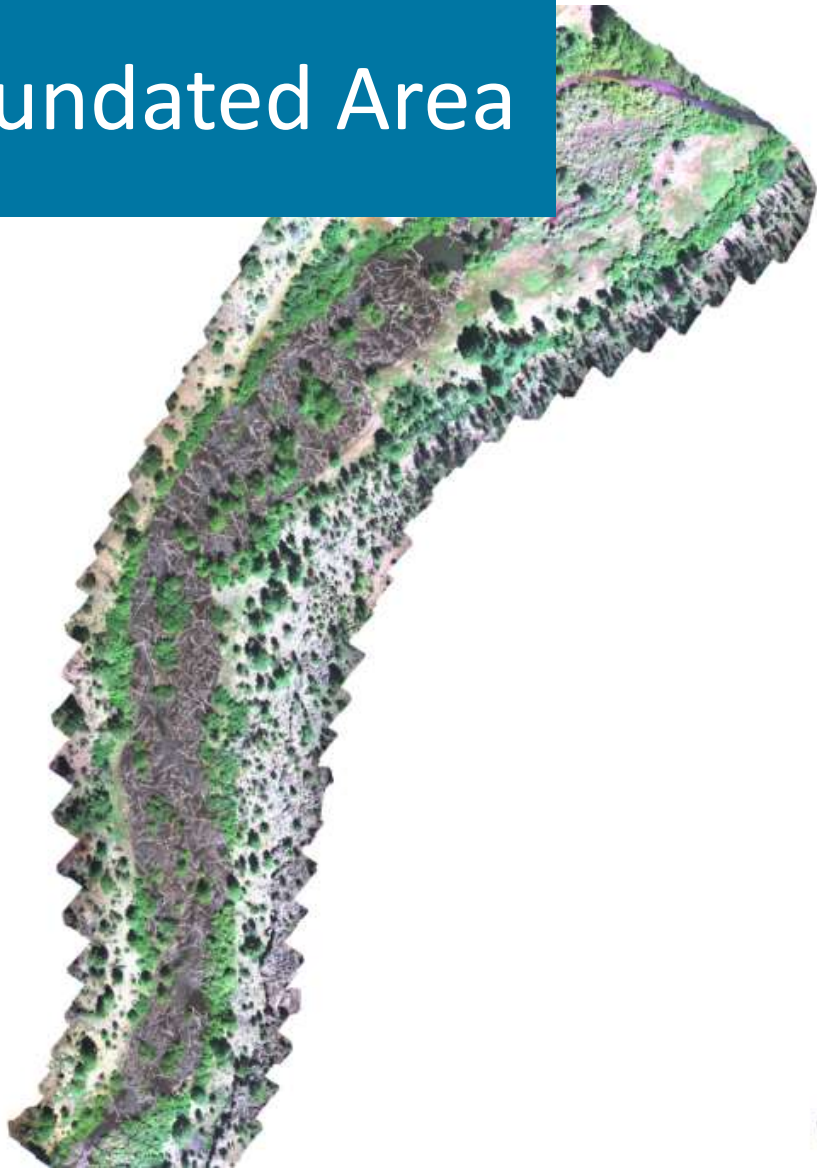
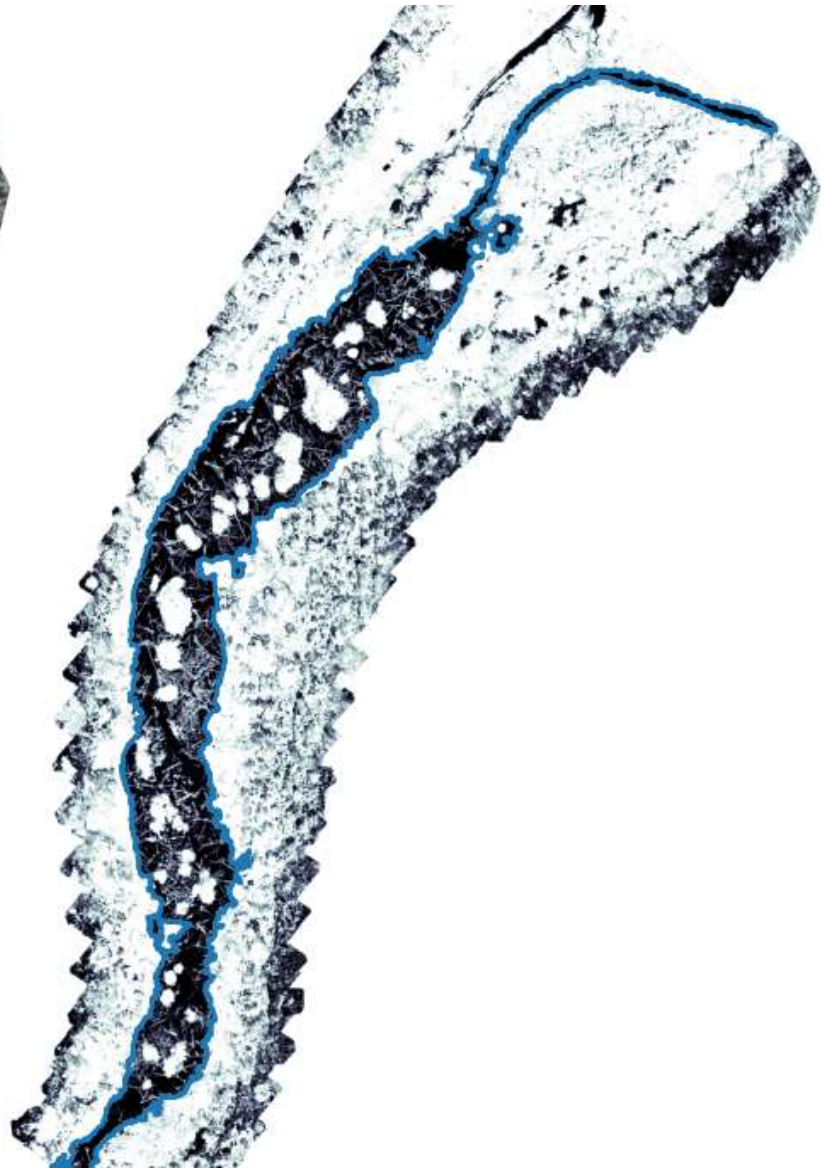
Inundated Area

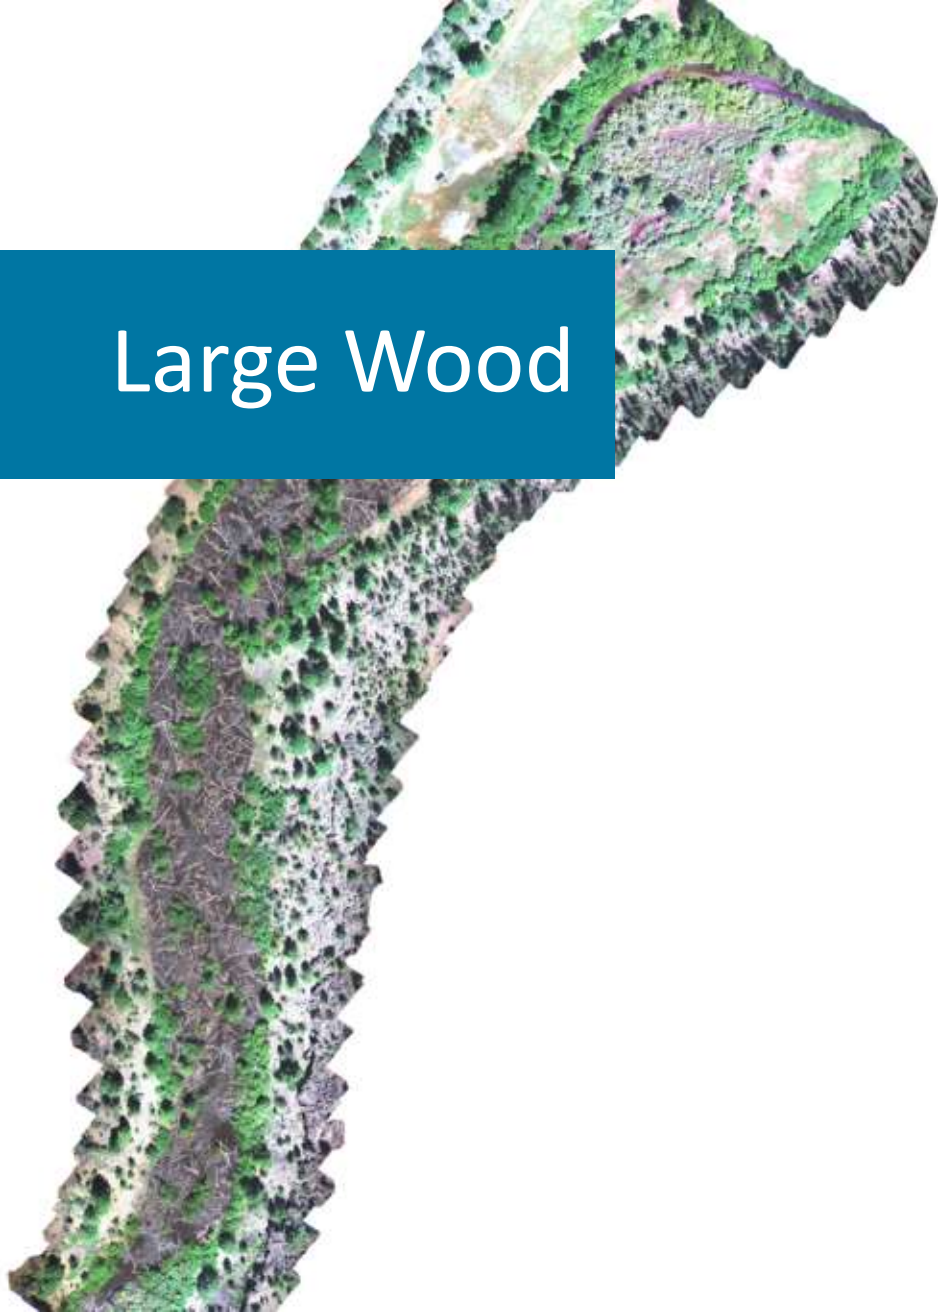
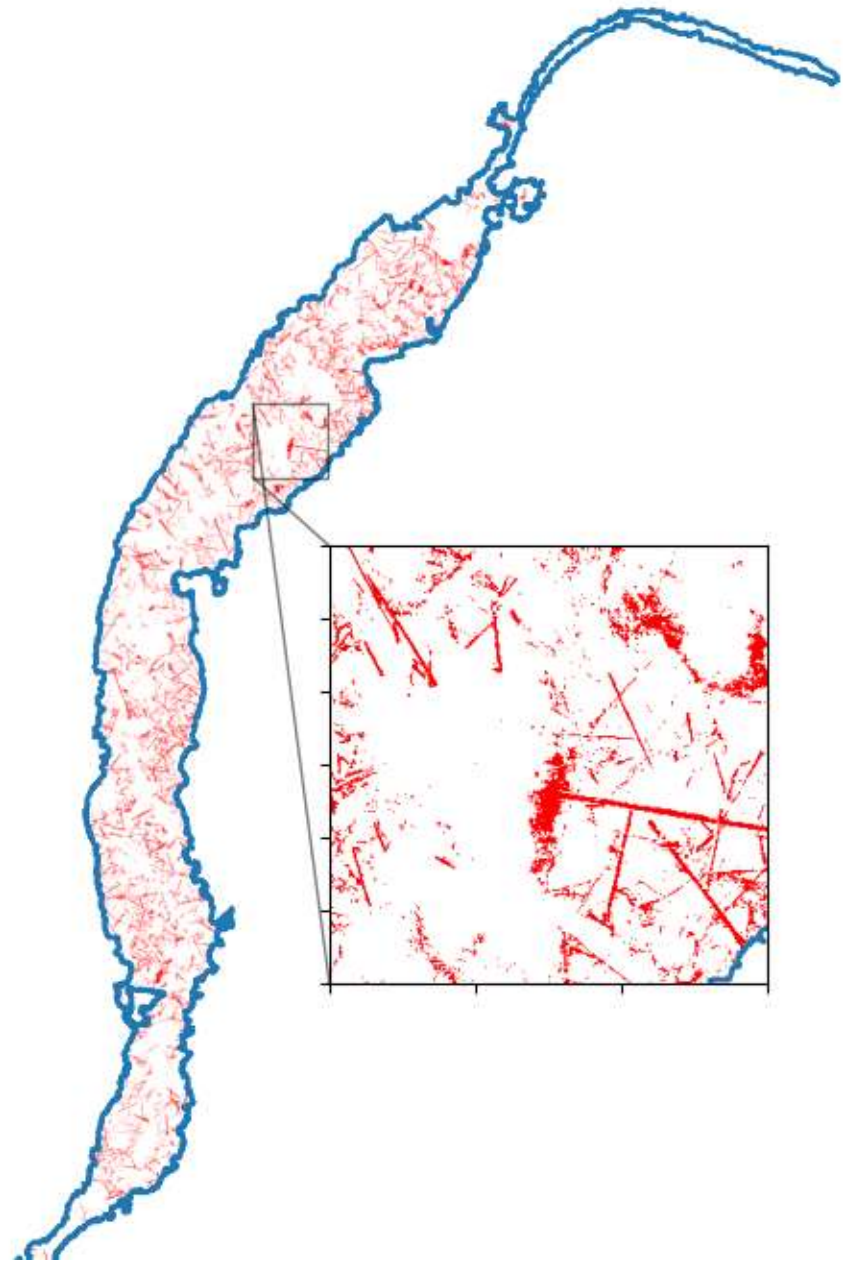
Large Wood
