Upper Little Patuxent Restoration

10 Years of Lessons Learned

Presented to: 2023 National Stream Restoration Conference

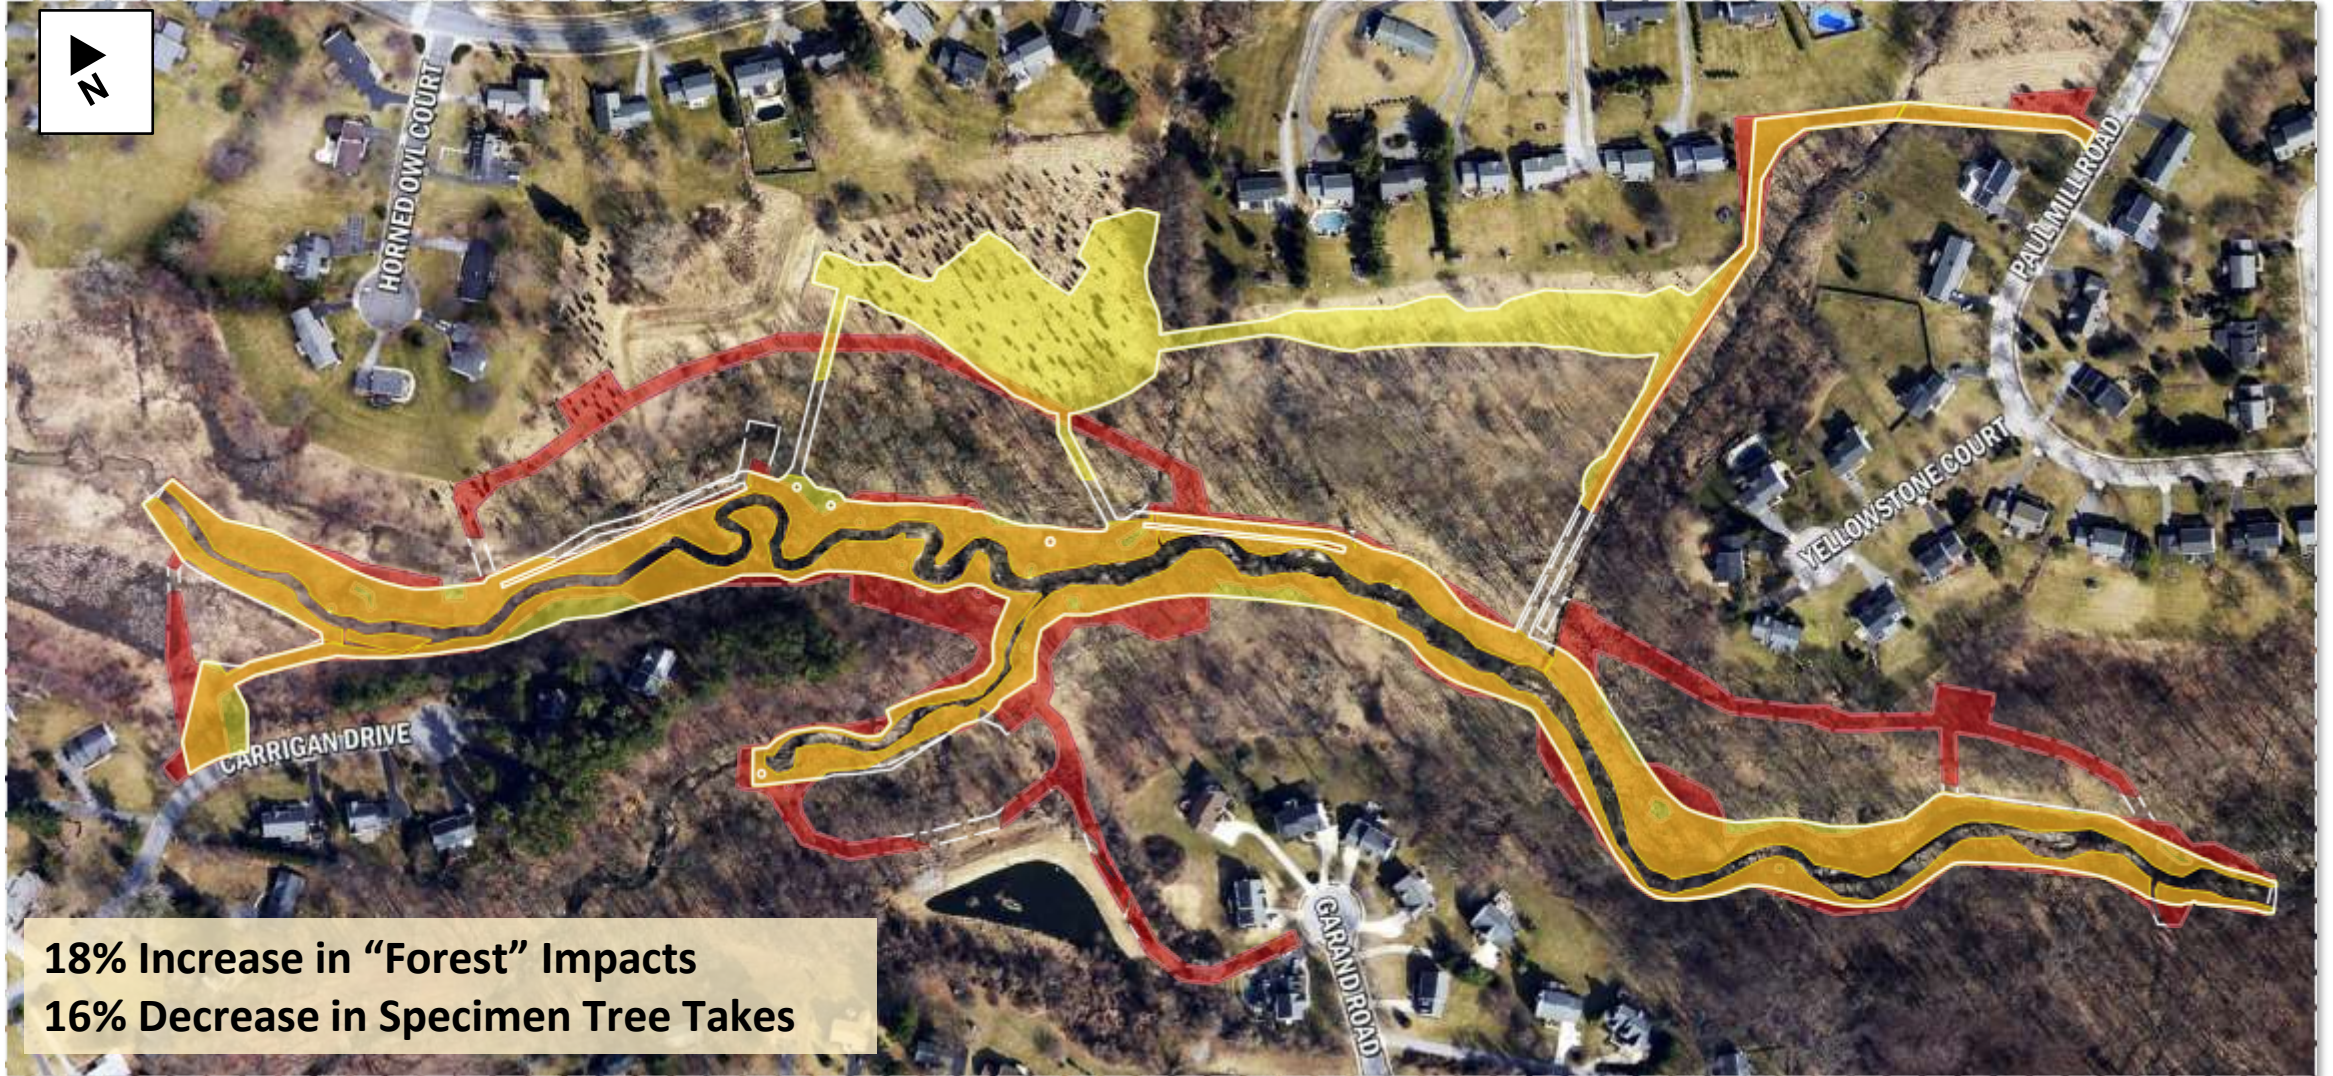
RFP Design

Final Design / As-built

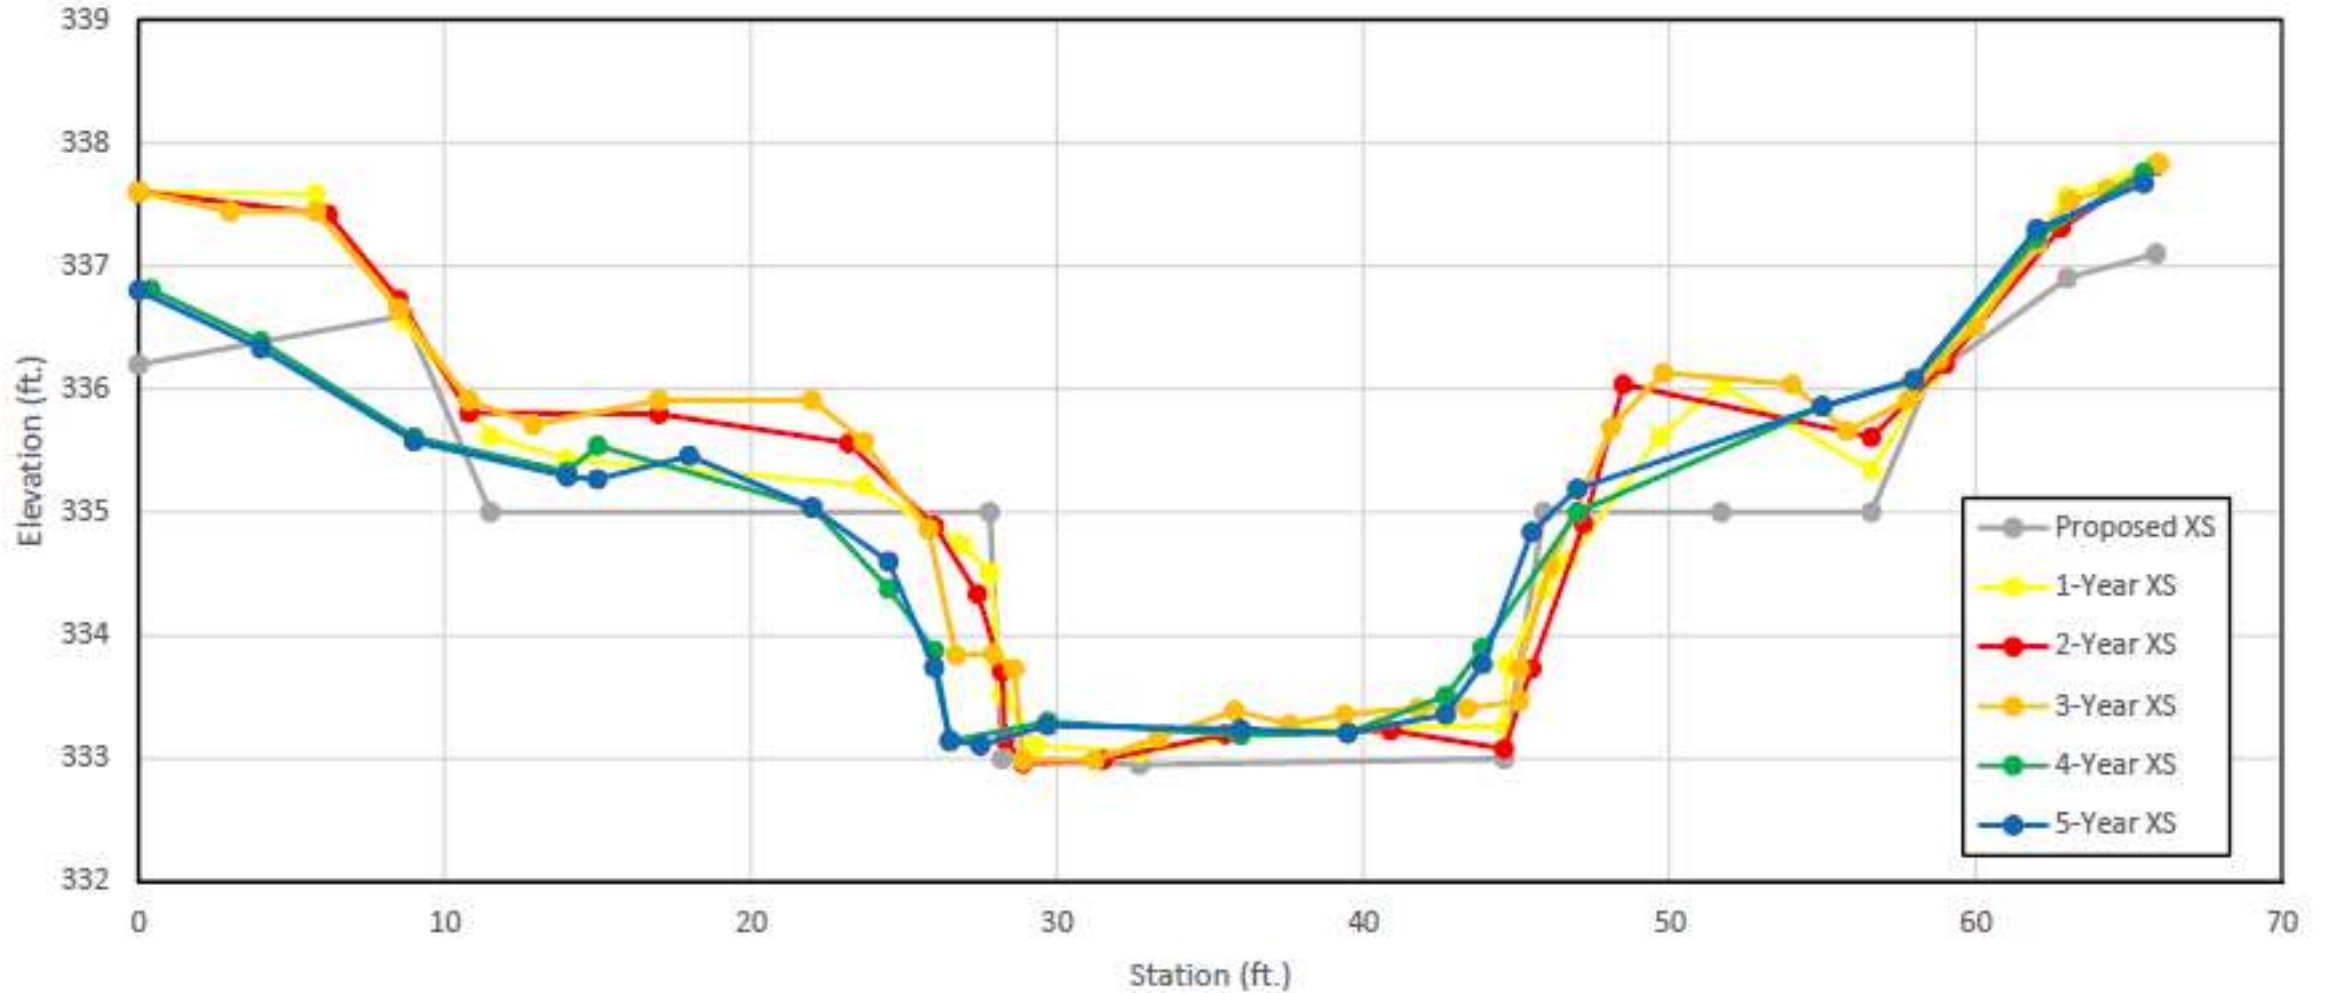
Upper Little Patuxent
Cross Section 1

3 Post Construction Monitoring - Section

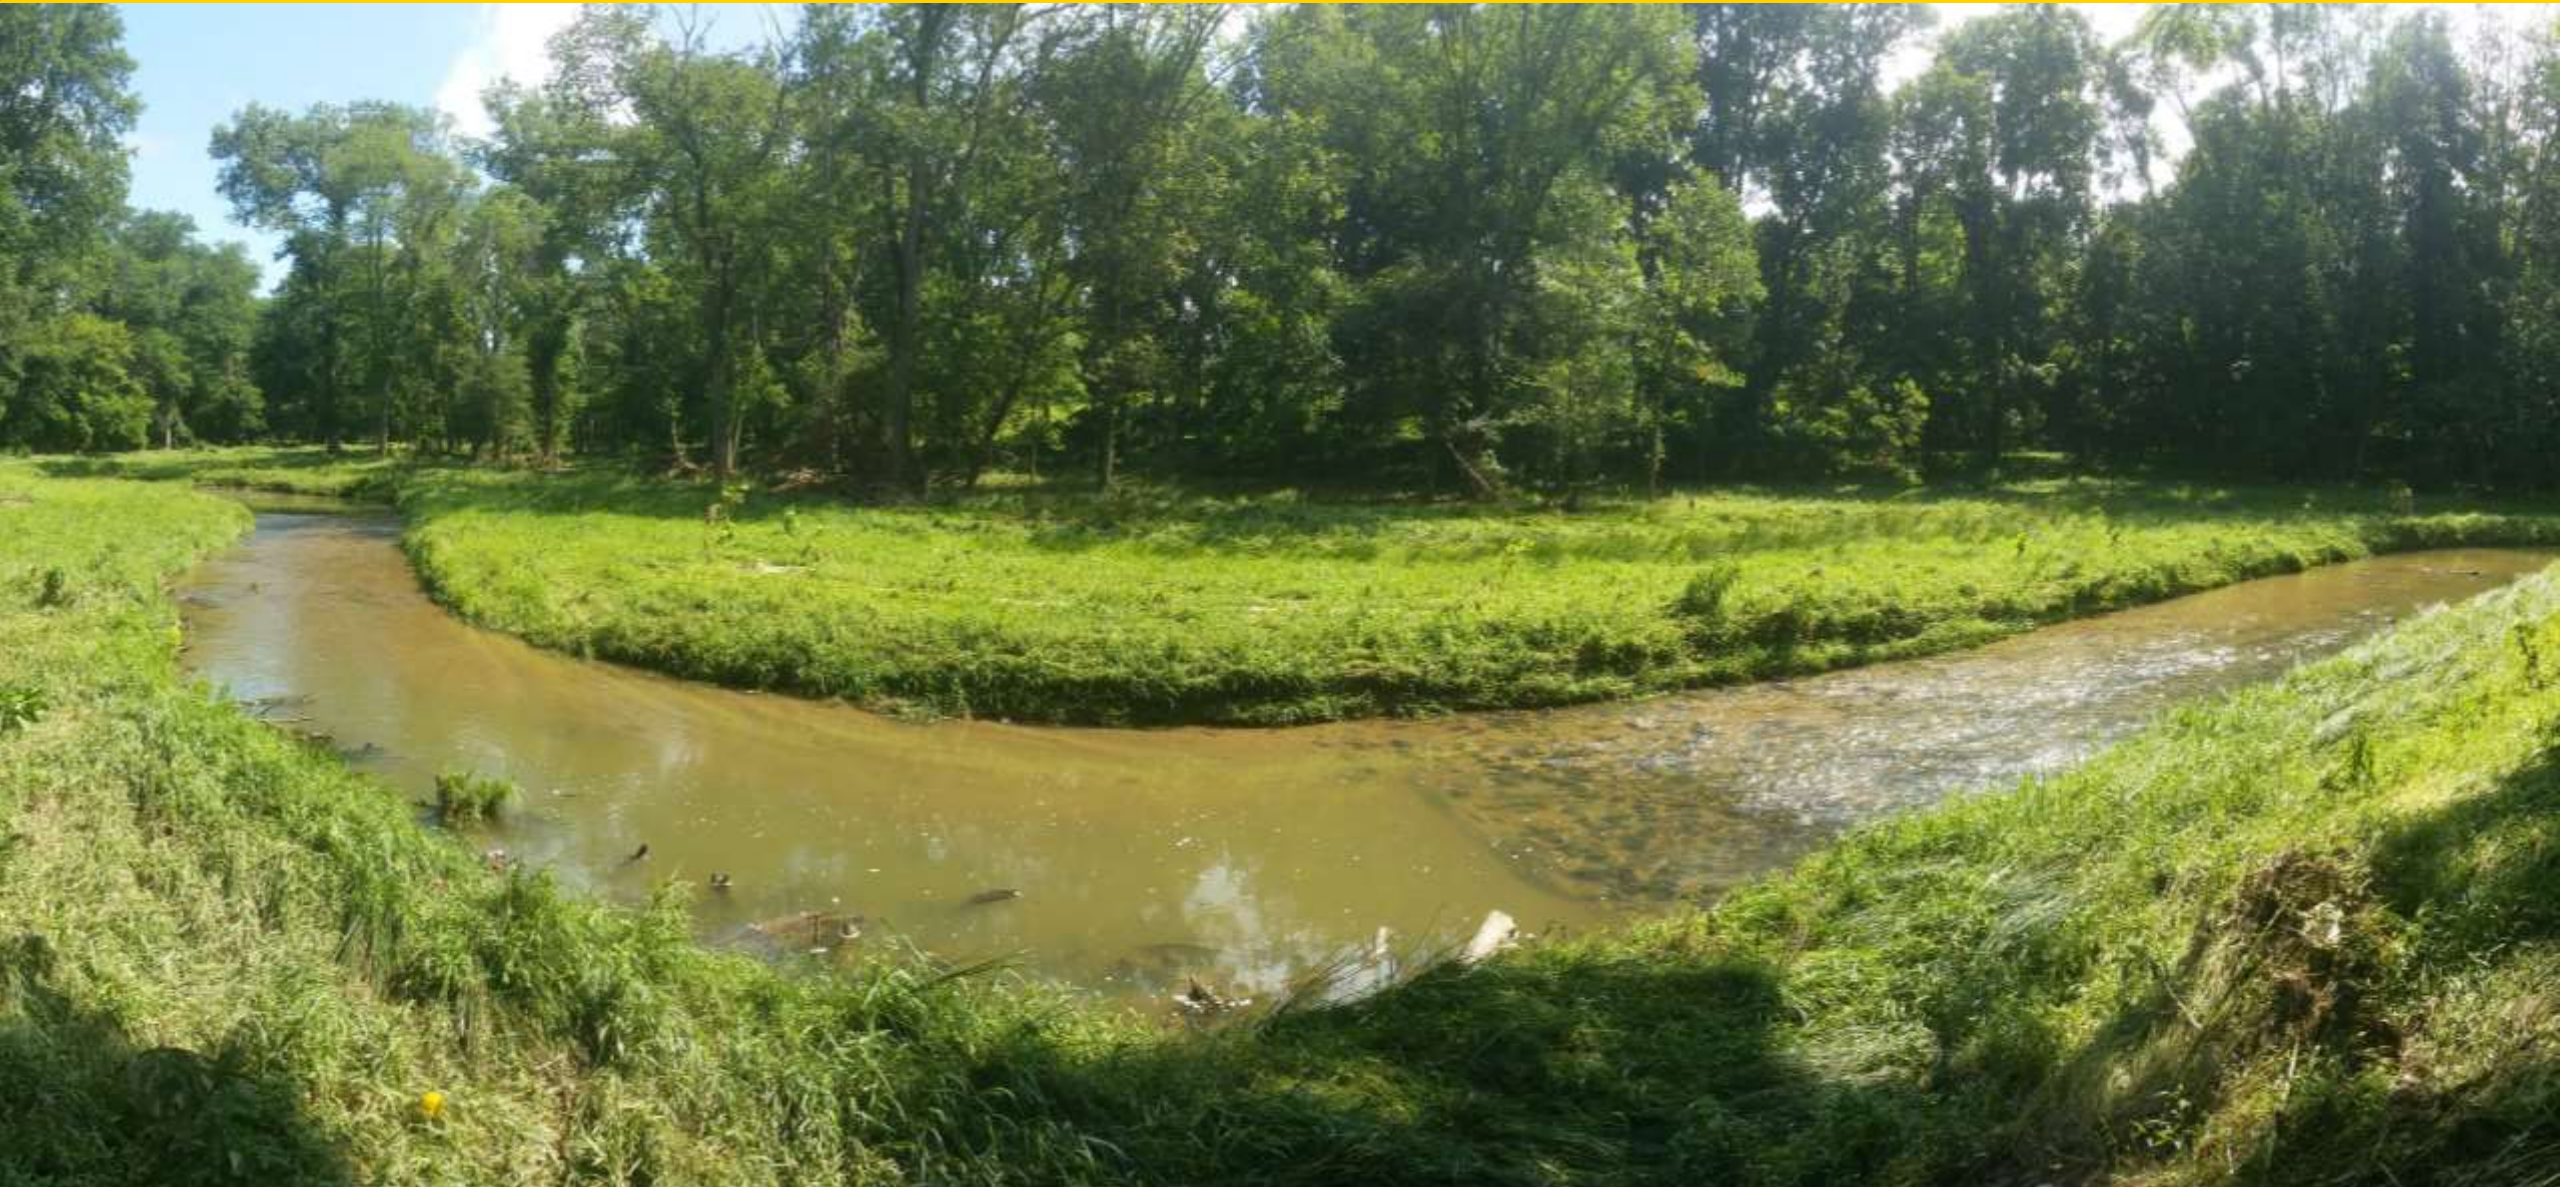
3 Post Construction Monitoring – Flood Performance, 2016

- June 30, 2016 – 6 in / 2 hours
- May 27, 2018 – 9.7 in / 2 hours
