# A NATURE BASED APPROACH FOR RESILIENT INFRASTRUCTURE SEPTA JENKINTOWN STREAM RESTORATION

AUGUST 22, 2023

PRESENTED TO: NATIONAL STREAM RESTORATION CONFERENCE 2023

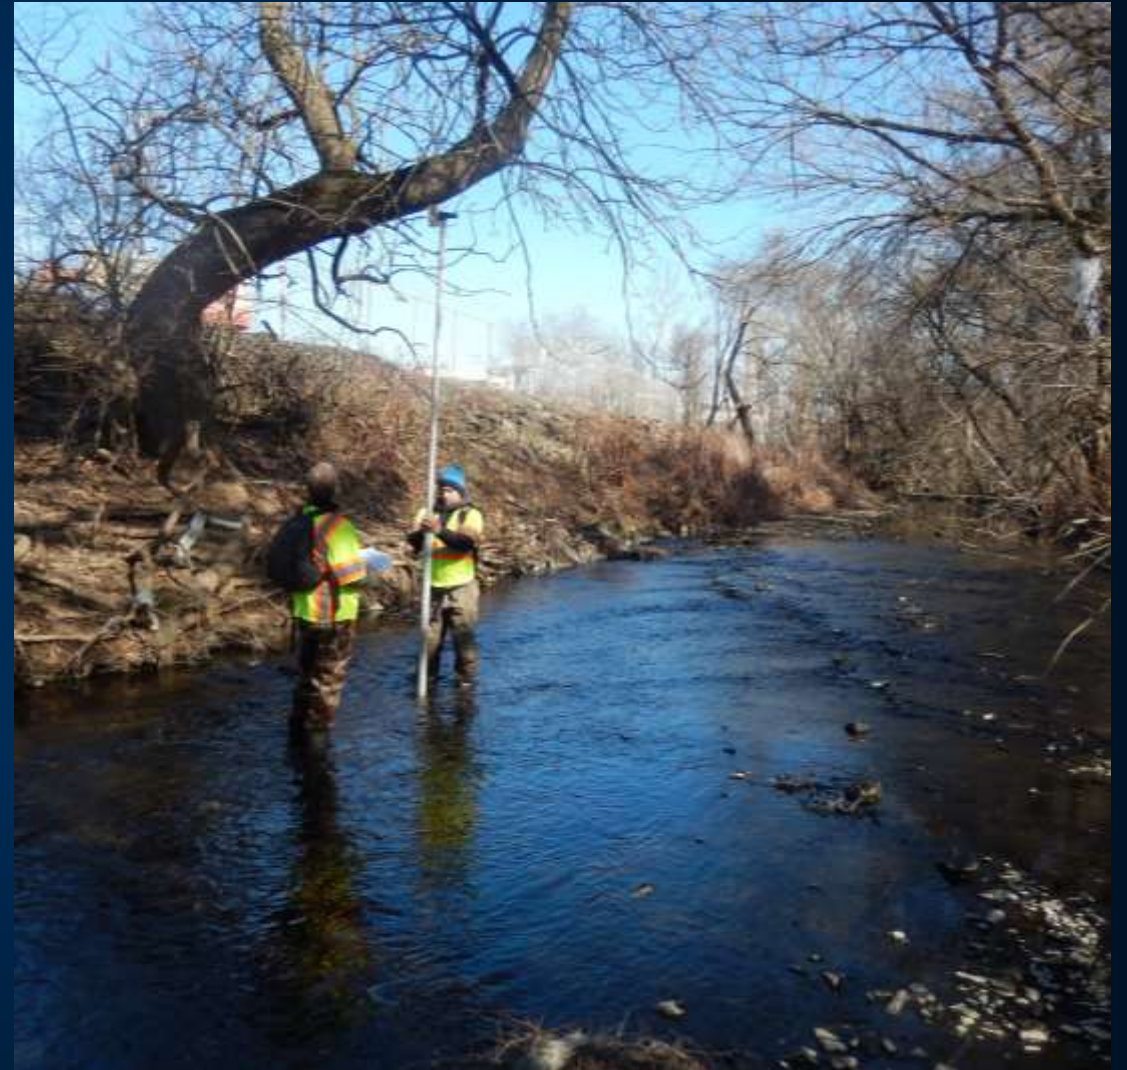
- Stream Corridor and Watershed Drainage Investigations
  - 10,000 LF Stream Channel Assessment
  - Watershed and Drainage Studies
  - Structural/Geotechnical Investigations
- Menu of Options
  - (3) Alternatives each location
  - Cost/Benefit Analysis
  - Preferred Alternative Selection
- H&H Modeling
  - HEC-RAS (1D) and TUFLOW (2D) Models
  - Verification of Recommendations
  - Quantitative Benefits
  - Design Efficiency

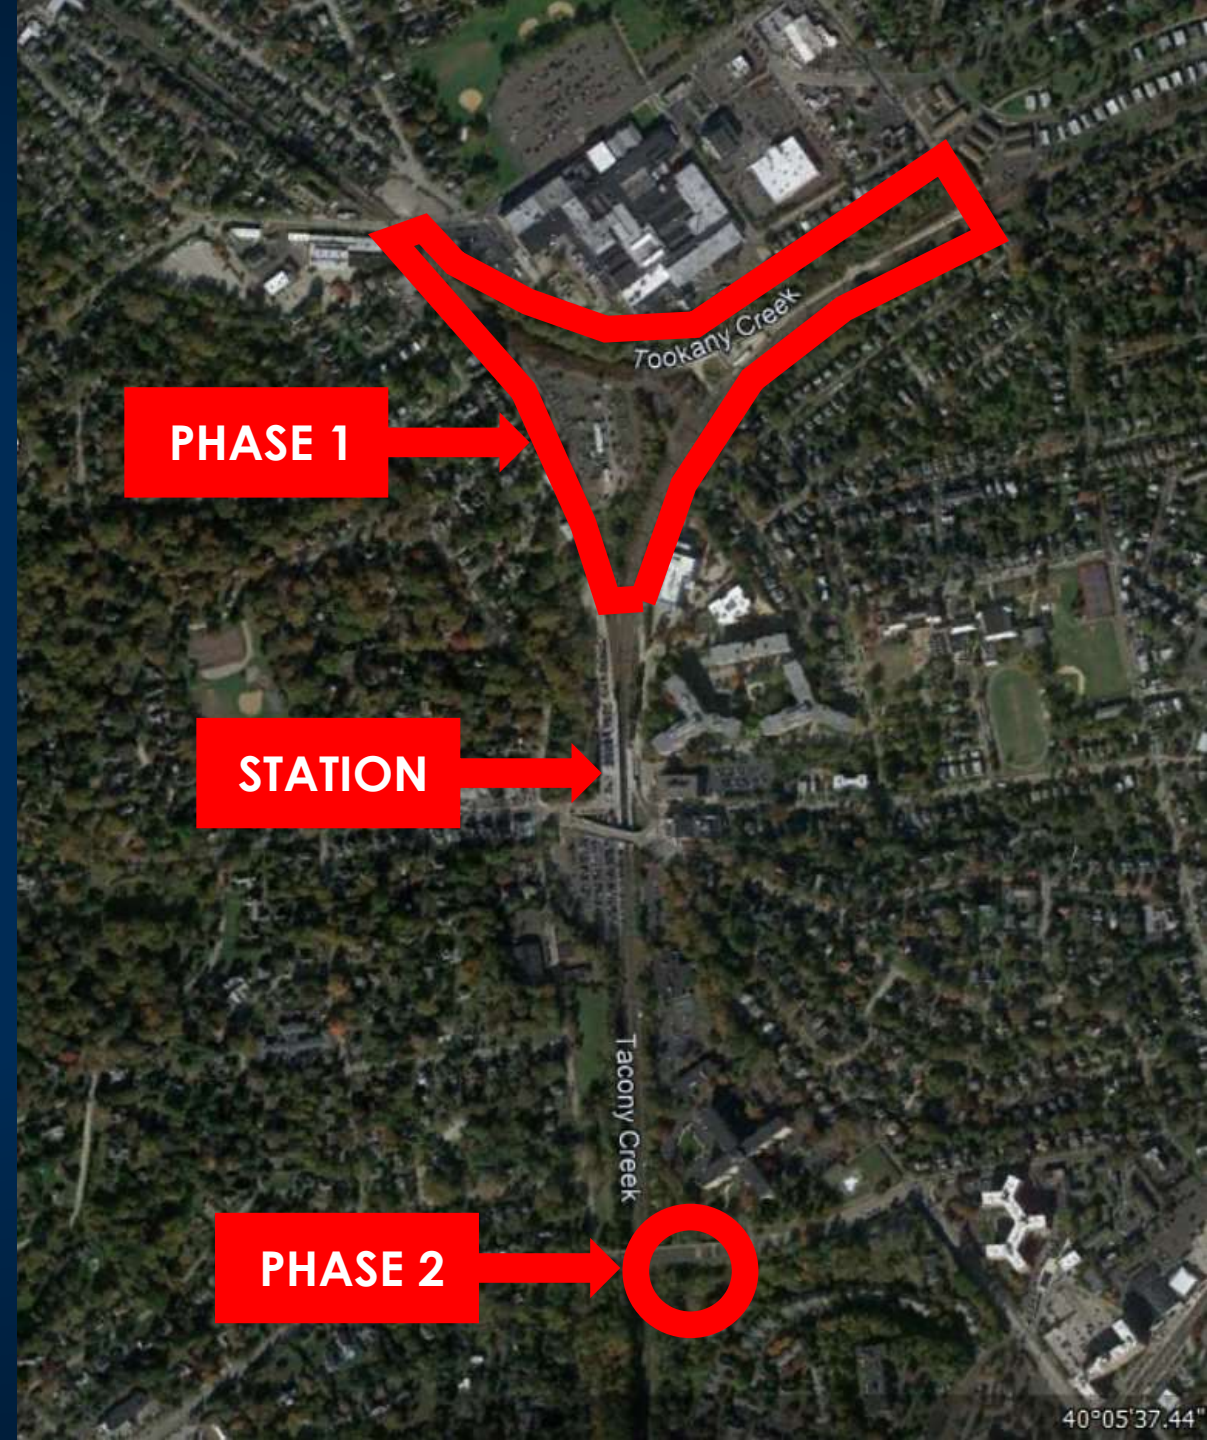
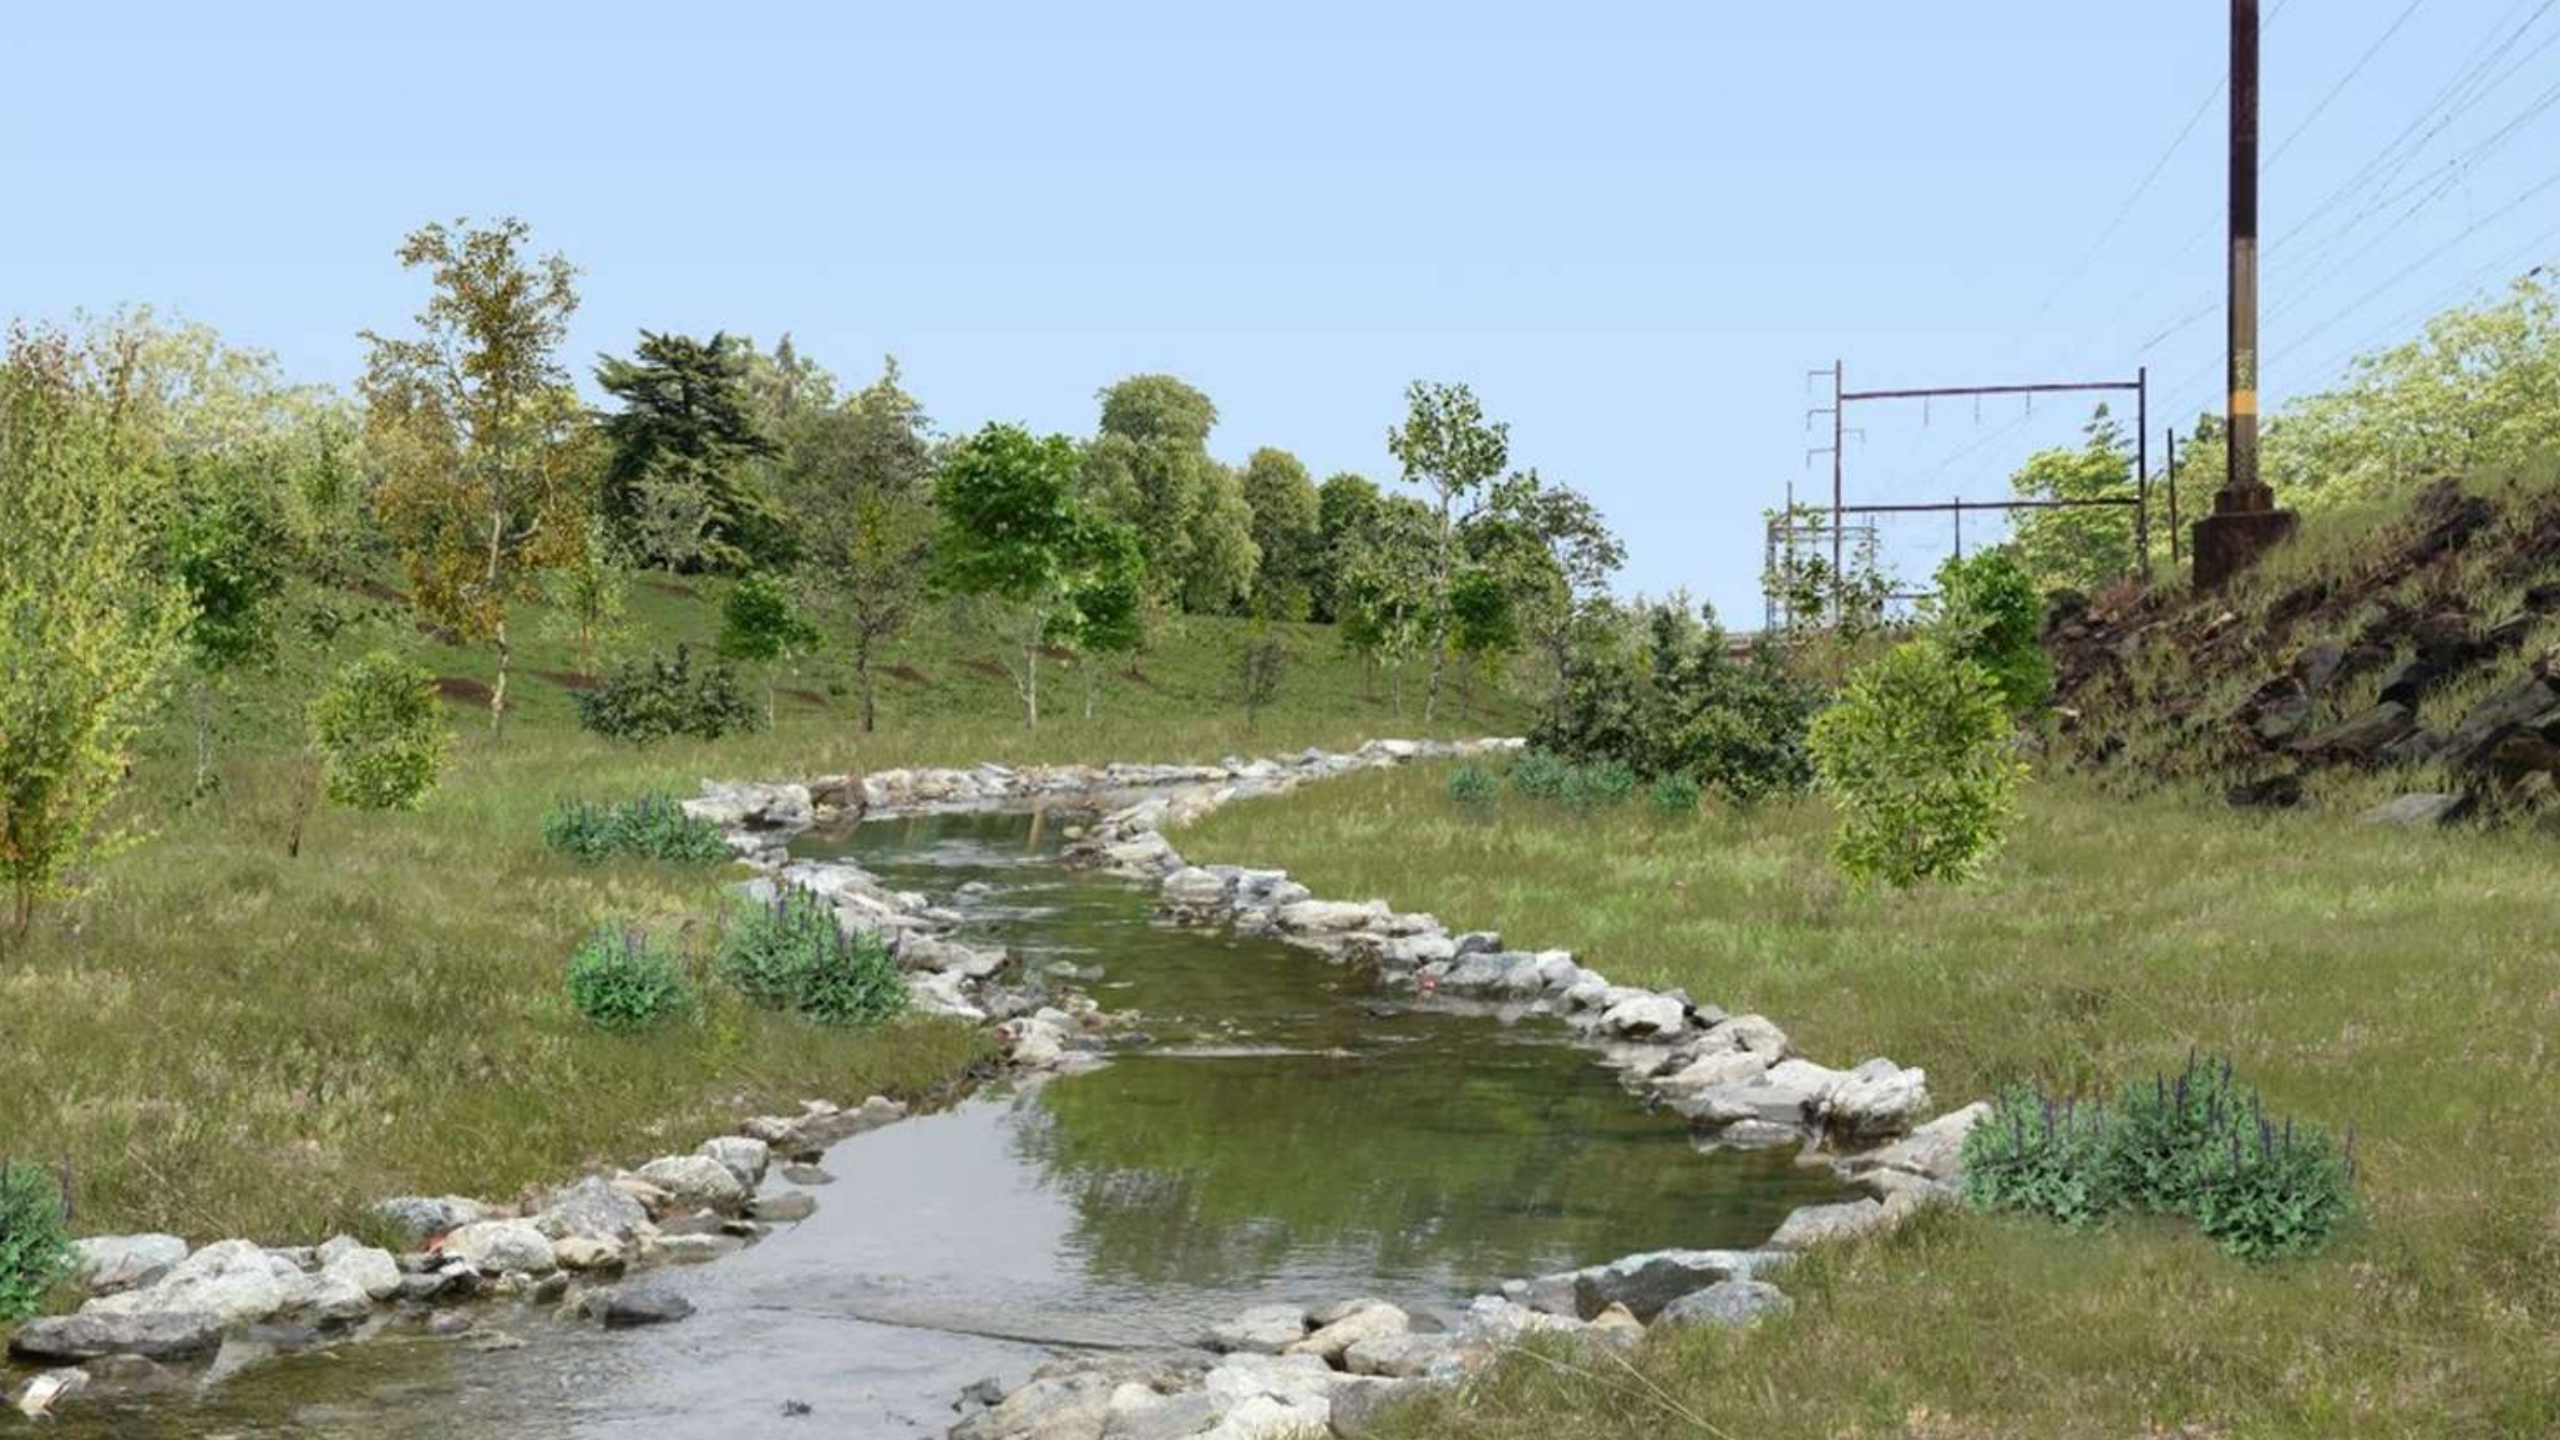
# FLOOD MITIGATION APPROACH

- Phase 1: Stream Restoration
- Phase 2: Culvert 10.38 Replacement
- Other Phases
  - 300 LF Stream Restoration at Bridge 11.22
  - Bridge 10.73 Replacement and 800 LF Stream Restoration at SEPTA Parking Lot
  - 1,200 LF Stream Restoration at Washington Lane

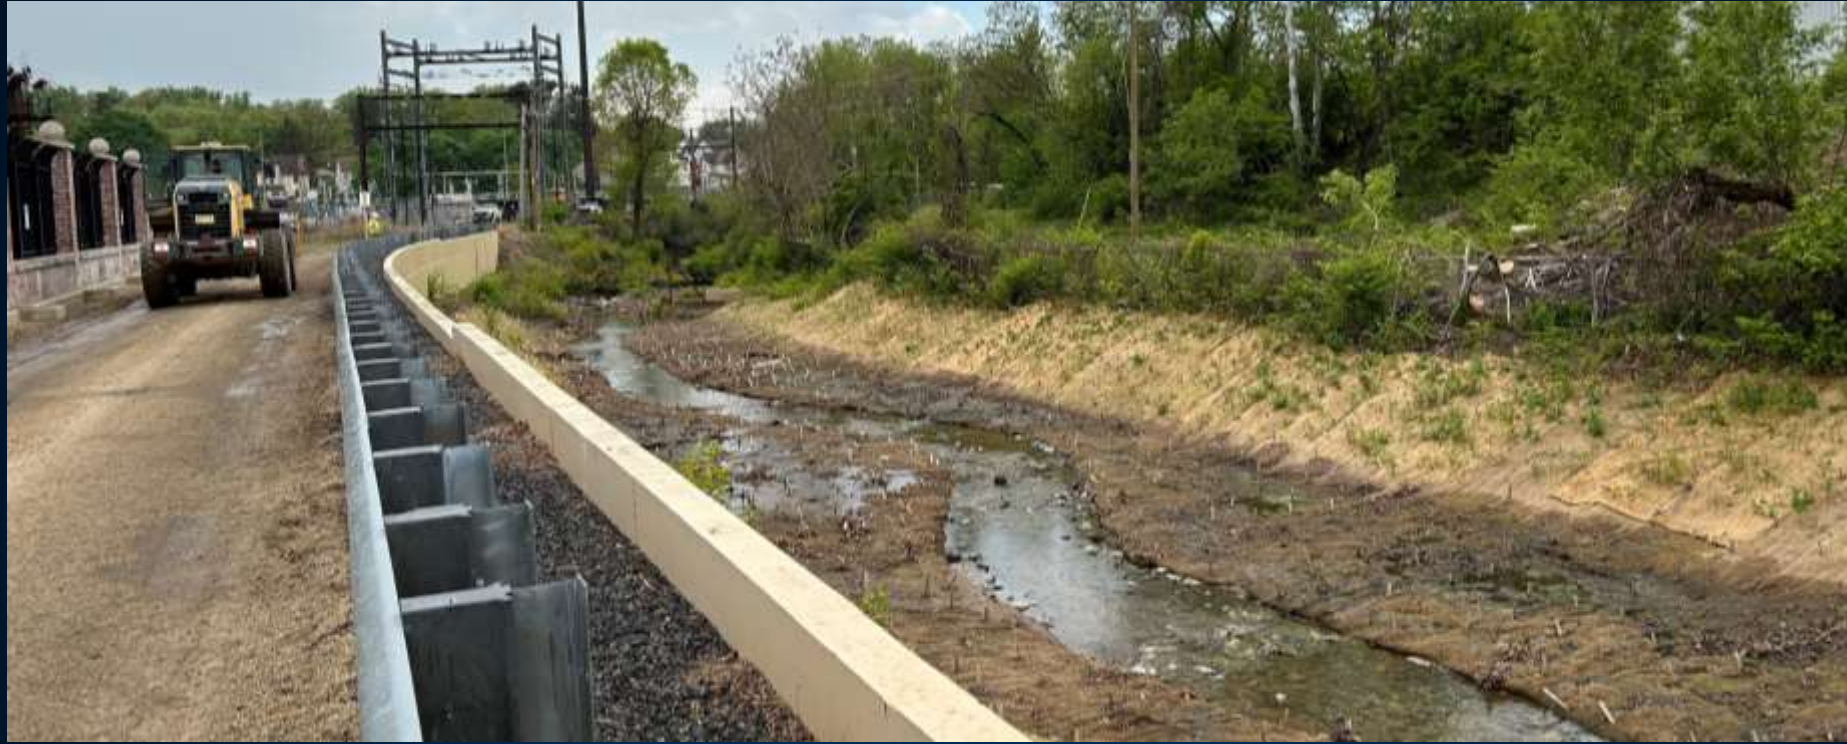
# PHASE 1: STREAM RESTORATION

## Baeder Run Stream Restoration

- >1,000 LF Stream and Floodplain Restoration
  - 350 LF Stream Channel Daylighted
- 0.5 Acre of Wetland Creation
- 270,000 CF of Additional Flood Storage

## Baeder Run Flood Overflow Storage Basin

- 90,000 CF of Additional Flood Storage

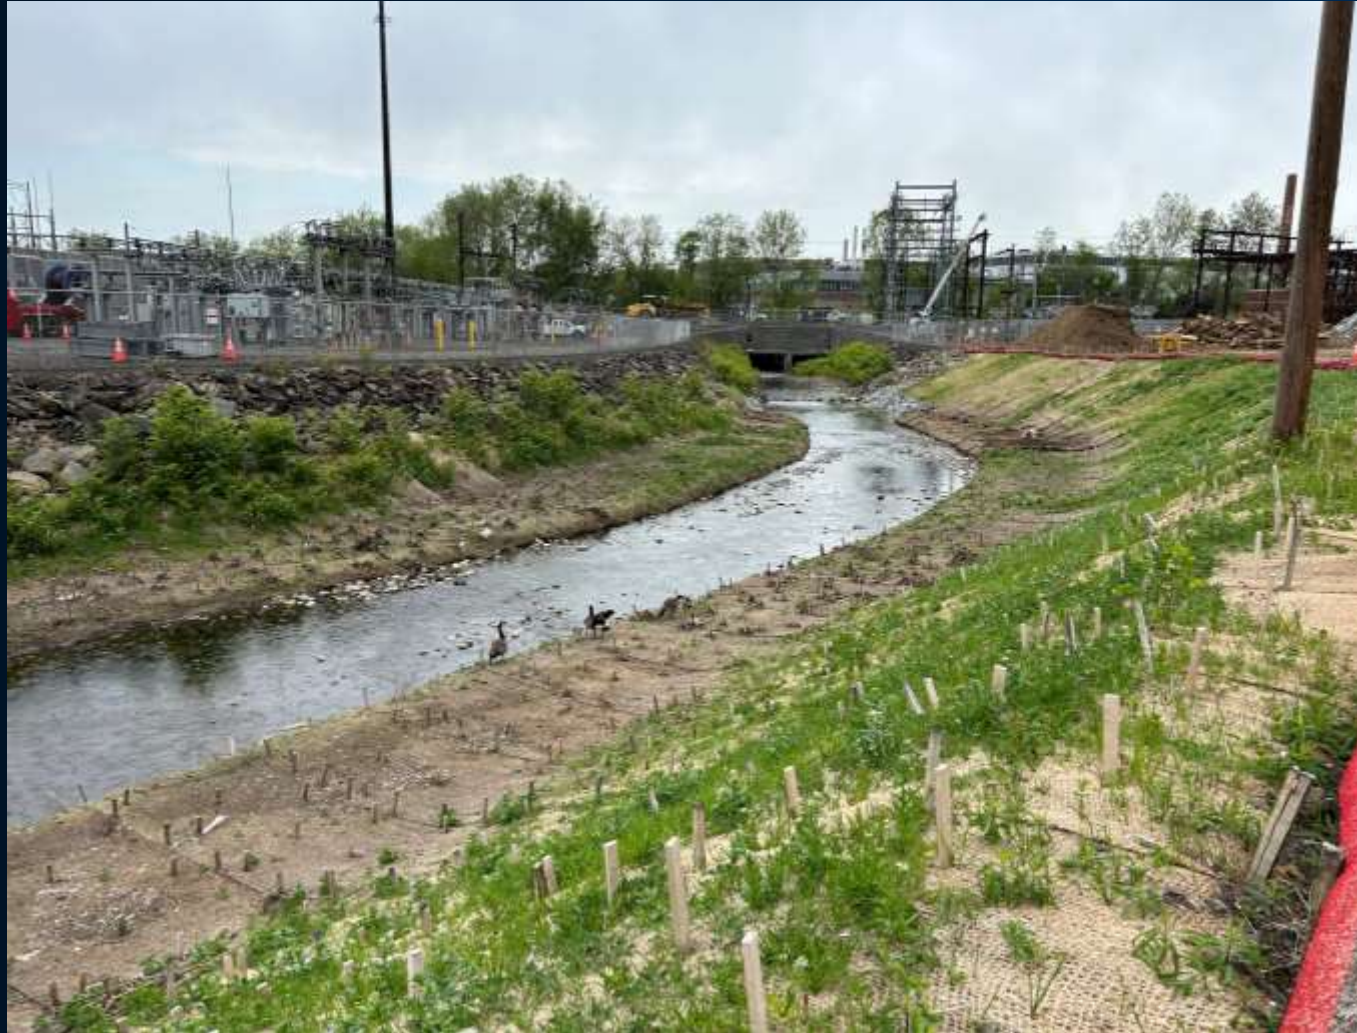
# PHASE 1: STREAM RESTORATION

## TACONY CREEK STREAM RESTORATION

- >600 LF Stream and Floodplain Restoration
- 0.5 Acre of Wetland Creation
- 210,000 CF of Additional Flood Storage

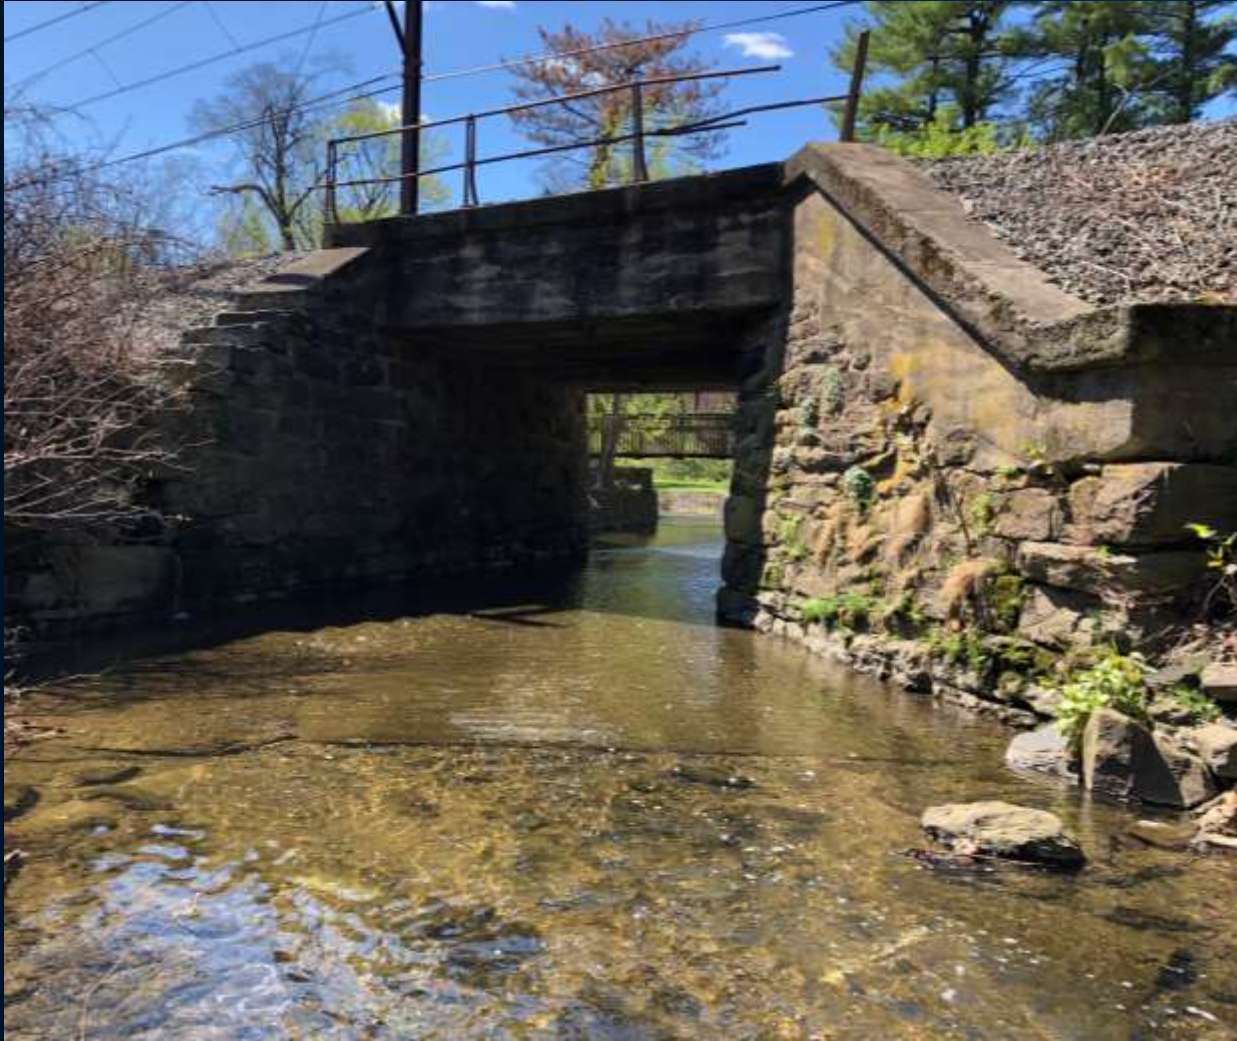
# PHASE 1: STREAM RESTORATION

## BRIDGE 0.16 REPLACEMENT

- Hydraulically Equivalent Single-Span Opening (CONSPAN) to Eliminate Center Pier (Maintenance Issue)

## BRIDGE 11.22 REHABILITATION

- Stone Repair and Repointing
- Replace Gabion Basket Retaining Walls
- Upstream Hydraulic Control for Tacony Creek

## BRIDGE 10.97 REHABILITATION

- Stone Repair and Repointing
- Downstream Hydraulic Control for Tacony Creek

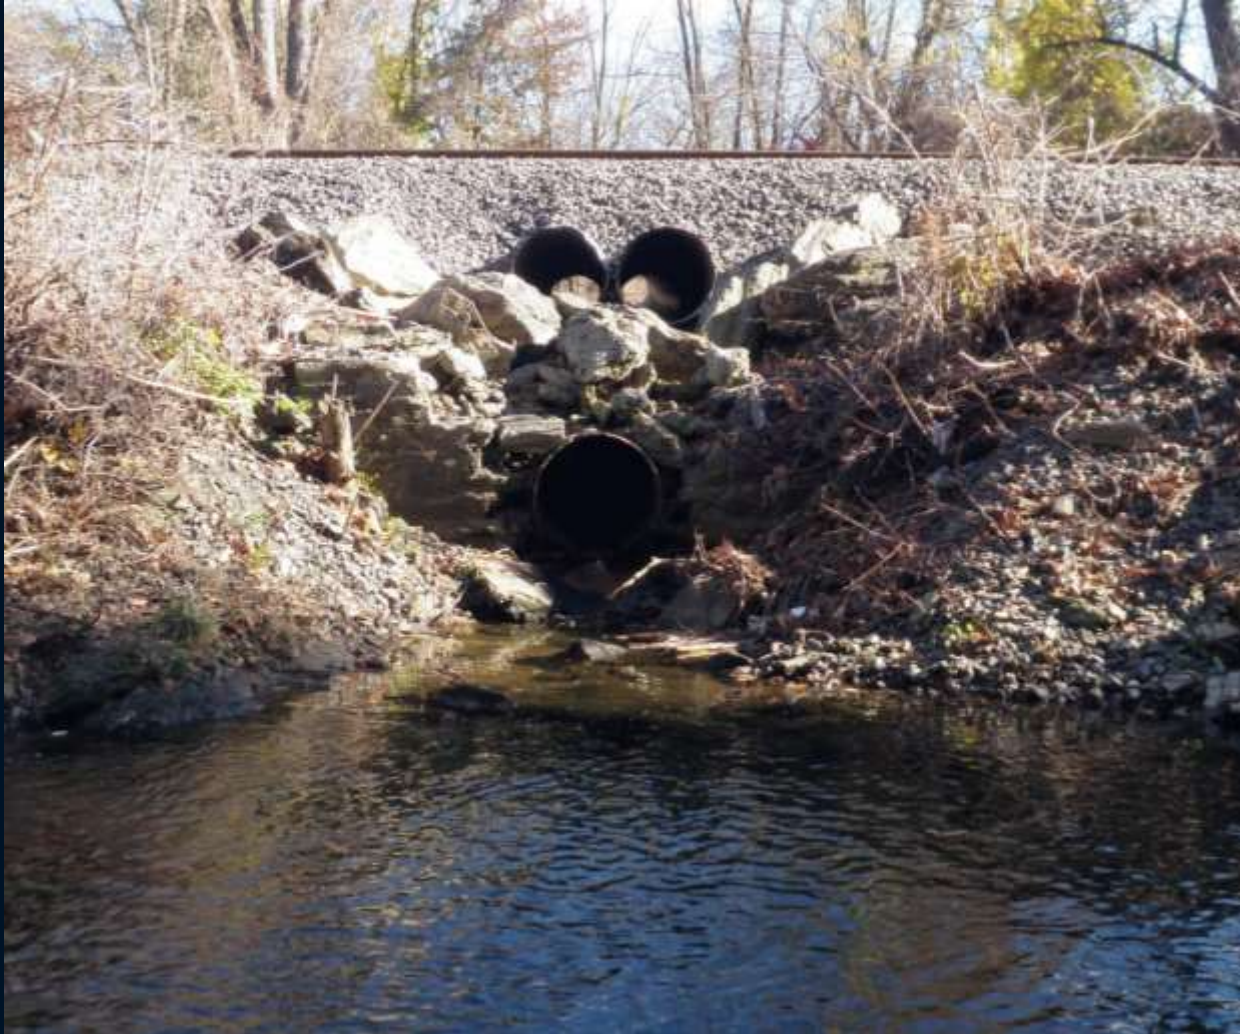
# PHASE 2: CULVERT 10.38 REPLACEMENT

## CULVERT 10.38 REPLACEMENT

- Track Ballast Blown Out During Tropical Storm Lee (2011)
- Major Track Outage and Service Delays
  - Located Between Philadelphia and Jenkintown Station
  - Interrupting Lansdowne/Doylestown, Westminster and West Trenton Lines
- 6'x8' Concrete Box Culvert to Replace Inefficient (3) Pipe Culvert System

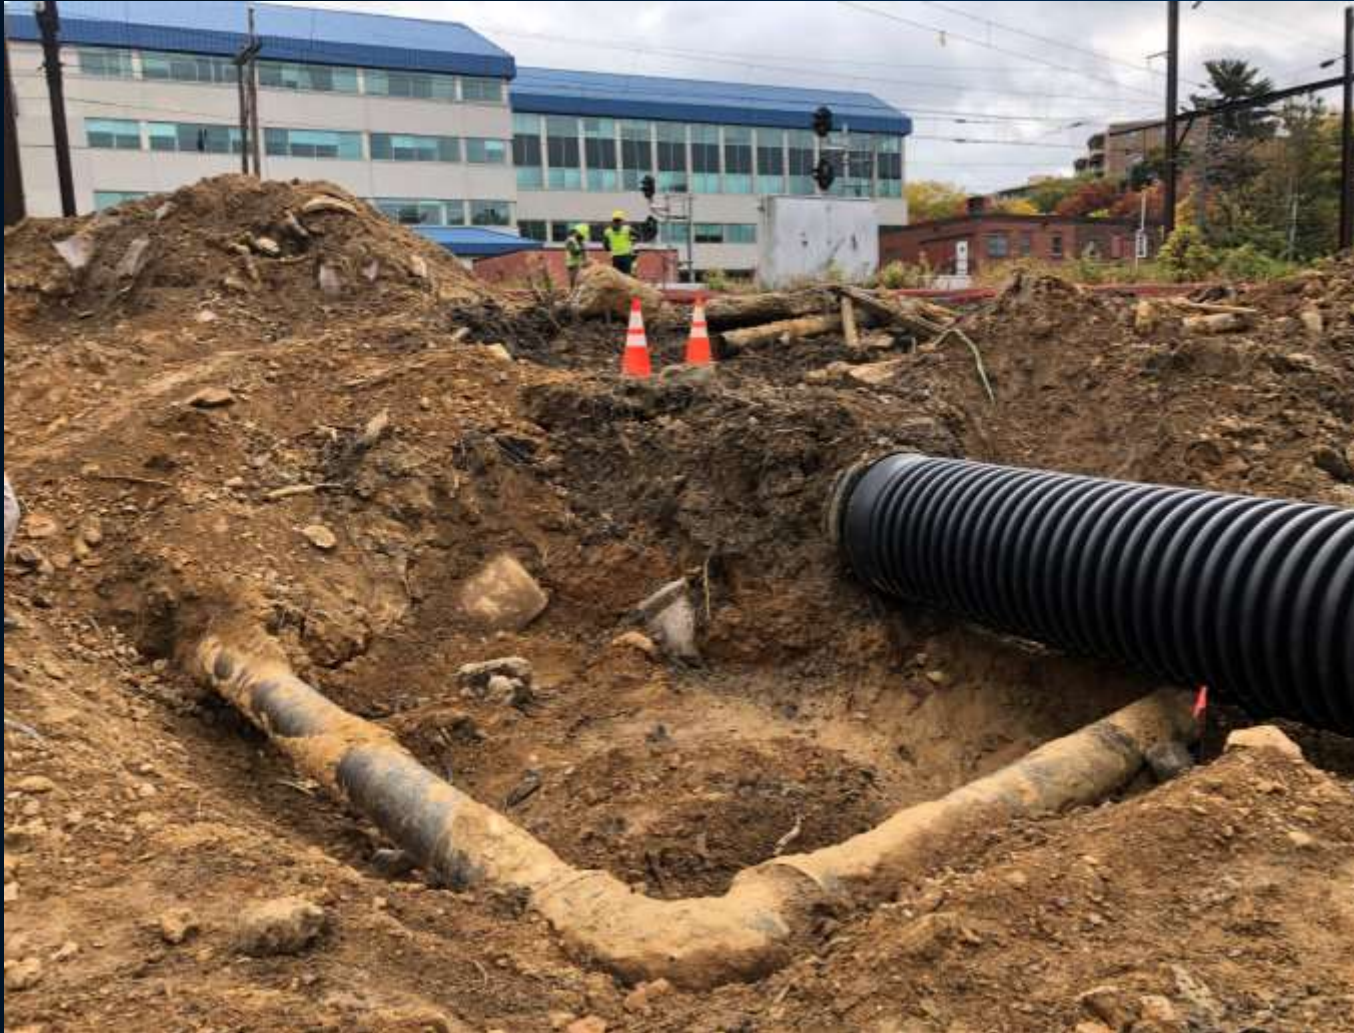
# UNDERGROUND UTILITIES

## CONSTRUCTION CONSIDERATIONS

- Unknown underground utilities
- Confirmation of underground utilities

## LESSONS LEARNED

- Perform exhaustive historical and record drawing review.
- Perform utility test pits for critical areas.

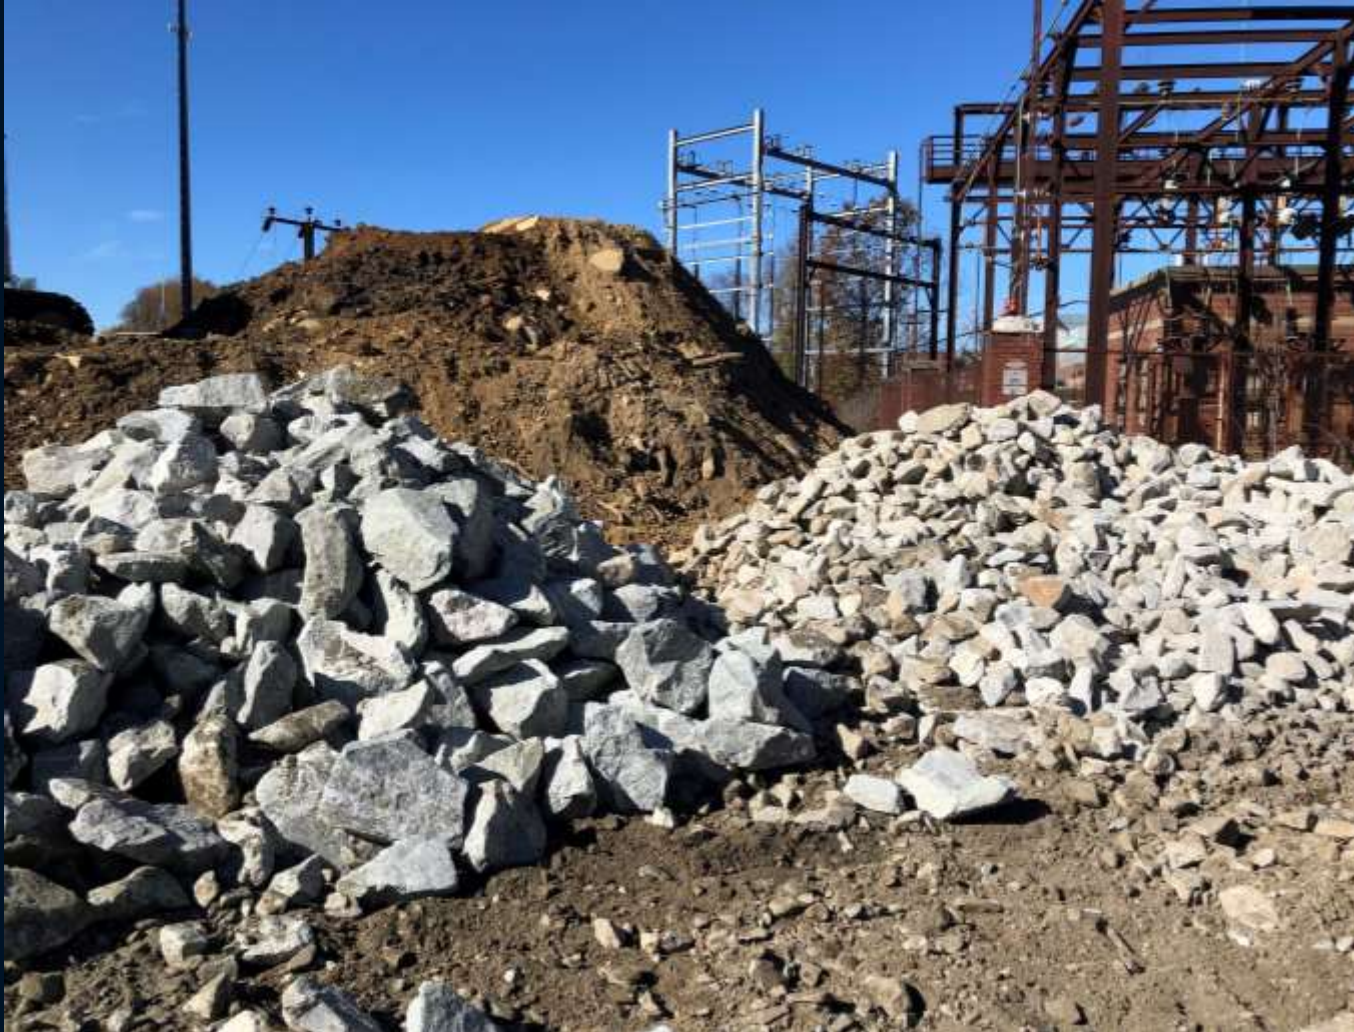
# SOIL TESTING

## CONSTRUCTION CONSIDERATION

- Classification of excavated soils
